Management Survey & Asbestos Register May 2012

**Spencer House
3 Spencer Parade
Northampton
NN1 5AA**

Survey and Assessment of Asbestos Containing Materials

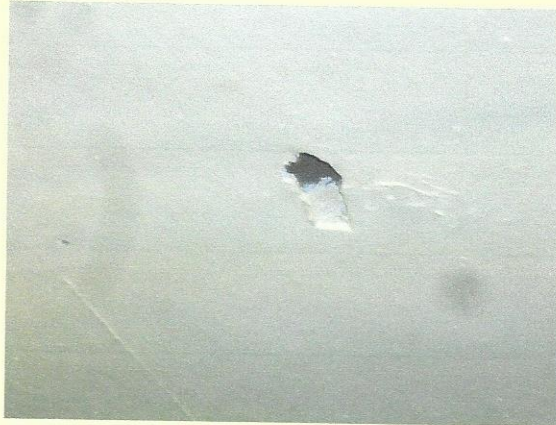
Sample No 170512/1/1

Item Insulating Board

Location Ceiling of Boiler room
/ Cellar

Lab Result NAD

Comments No Asbestos Detected - Inert material

Recommended Action Non Required
