# **Asbestos Survey Report**

**Project Ref. No: 1/8  
07/04/14/01**

Level 2 Basement Plant Area  
Gas and Electrical intake areas only.  
46 New Broad Street  
London  
EC2M 1JH

**Survey Date:** 14 Oct 2015  
**Surveyor:** Peter Farsch  
**Report Print Date:** 14 December 2015  
**Report Authorised By:** Peter Farsch

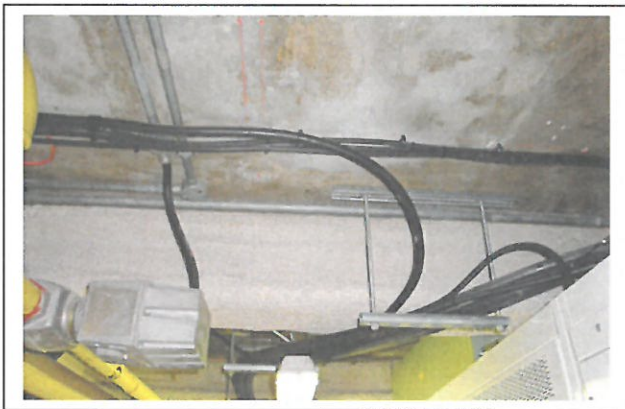
Fire protection to beam – Electrical intake room

Inspection Dates:	09 - 10 - 2015	Reference No.:	Sample 01
Surveyors:	AR + PF	Survey Type:	Management Survey
Component:	Sprayed fire protection to beam	Approx Amount:	NA
Asbestos?	NAD		
Asbestos type(s):	NAD

Product Type:	0 Non ACM	Accessibility:	
Surface:		Position:	
Condition:		Friability:	
Abs Type:	0 No Asbestos Detected	RISK:	<b>NONE</b>

Note: the component was found not to be an ACM.

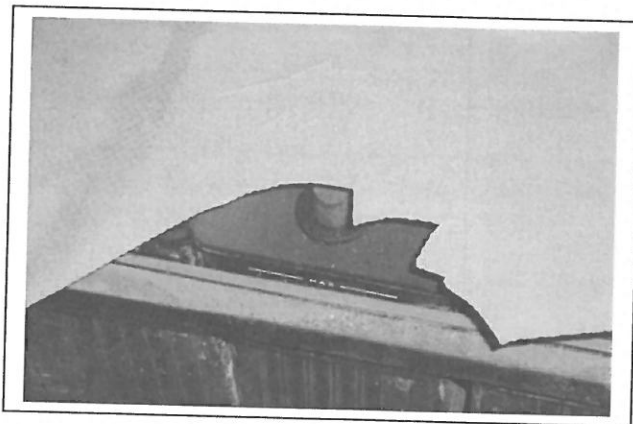
**Battery / Store Room debris of broken panel**

<b>Inspection Dates:</b>	09 - 10 - 2015	<b>Reference No.:</b>	Sample 021
<b>Surveyors:</b>	AR + PF	<b>Survey Type:</b>	Management survey
<b>Component:</b>	Debris of broken panel	<b>Approx Amount:</b>	NA
<b>Asbestos?</b>	NAD		
<b>Asbestos type(s):</b>	NAD

<b>Product Type:</b>	0 Non ACM	<b>Accessibility:</b>	
<b>Surface:</b>		<b>Position:</b>	
<b>Condition:</b>		<b>Friability:</b>	
<b>Abs Type:</b>	0 No Asbestos Detected	<b>RISK:</b>	<b>NONE</b>

Note: the component was found not to be an ACM.

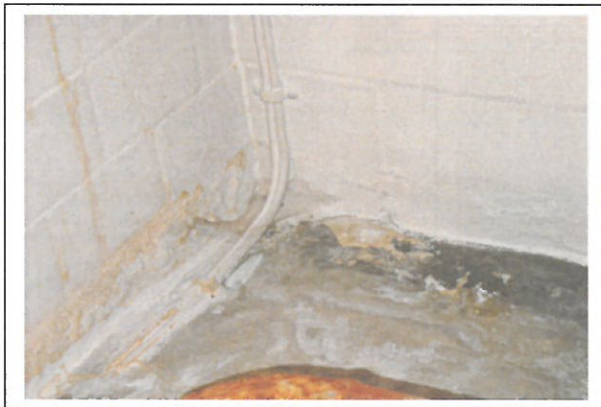
**General – Gas intake room – tanking to floor.**

<b>Inspection Dates:</b>	09 - 10 - 2015	<b>Reference No.:</b>	Sample 03
<b>Surveyors:</b>	AR + PF	<b>Survey Type:</b>	Management survey
<b>Component:</b>	Tanking to floor	<b>Approx Amount:</b>	NA
<b>Asbestos?</b>	NAD		
<b>Asbestos type(s):</b>	NAD

<b>Product Type:</b>	0 Non ACM	<b>Accessibility:</b>	
<b>Surface:</b>		<b>Position:</b>	
<b>Condition:</b>		<b>Friability:</b>	
<b>Abs Type:</b>	0 No Asbestos Detected	<b>RISK:</b>	<b>NONE</b>

Note: the component was found not to be an ACM.

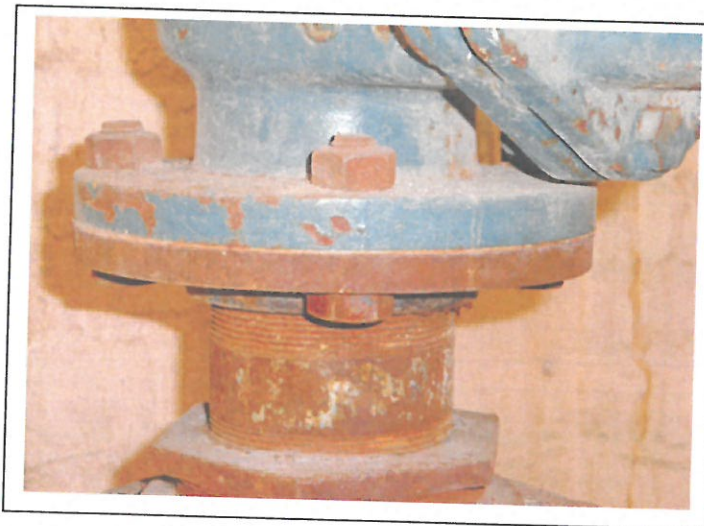
Gasket taken for outlet vale to pipe – similar gaskets between flanges to pipes.

Ref : 04	Gasket	Next action due date:	Monitor annually for damage.
Remedial action:	Inspect		
Timescale:	ASAP if showing signs of damage Replace	Approx. Quantity:	Approx 9
Location-component:	Gaskets bolted between flanges of pipes to seal the joints on the Gas Pipes.

Inspection Dates:	07-04-14	Reference No.:	04
Surveyor:	AR+ PF	Survey Type:	Management Survey
Component:	Gasket	Approx Amount:	2 x 14m <sup>2</sup>
Asbestos?	YES		
Asbestos type(s):	Chrysotile

Product Type:	4 AIB, rope, gaskets, woven	Accessibility:	0 Low
Surface:	4 Not Sealed	Position:	1 Internal
Condition:	0 Good	Friability:	0 Low
Abs Type:	1 Chrysotile Alone	RISK:	LOW (9)

Gasket situated between flanged joints of gas pipes.

In current position this material is safe - looked to be in good condition with no damage visible at the time of visit. Do not dismantle pipe work joints – if works to refurbish the gas installation is contemplated licensed Asbestos contractors should be contacted with a view to removing the material from any affected pipe works.

Check annually for damage. In the very unlikely event of damage replace with a non ACM material.

Label as per General Information of report – warn all maintenance persons of the location of the material.

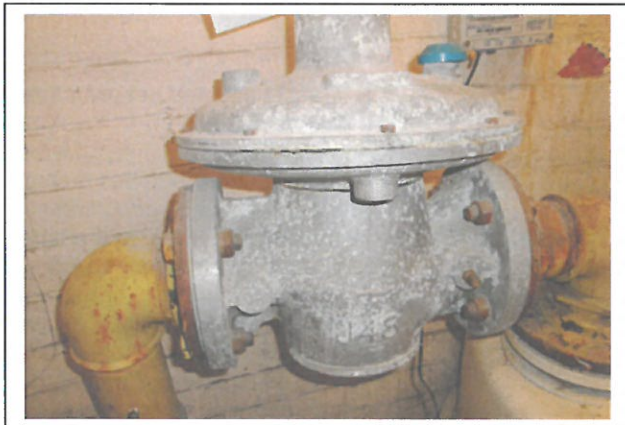
**Gasket to inlet Valve**

<b>Inspection Dates:</b>	09 - 10 - 2015	<b>Reference No.:</b>	Sample 05
<b>Surveyors:</b>	AR + PF	<b>Survey Type:</b>	Management Survey
<b>Component:</b>	Gasket	<b>Approx Amount:</b>	NA
<b>Asbestos?</b>	NAD		
<b>Asbestos type(s):</b>	NAD

<b>Product Type:</b>	0 Non ACM	<b>Accessibility:</b>	
<b>Surface:</b>		<b>Position:</b>	
<b>Condition:</b>		<b>Friability:</b>	
<b>Abs Type:</b>	0 No Asbestos Detected	<b>RISK:</b>	<b>NONE</b>

Note: the component was found not to be an ACM.

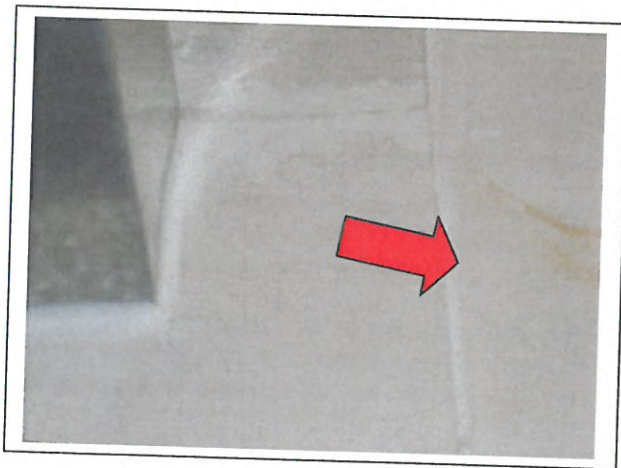
**Gas Intake Room Panel to frame above the door.**

<b>Inspection Dates:</b>	09 - 10 - 2015	<b>Reference No.:</b>	Sample 06
<b>Surveyors:</b>	AR + PF	<b>Survey Type:</b>	Management Survey
<b>Component:</b>	Fire Resistant panel.	<b>Approx Amount:</b>	NA
<b>Asbestos?</b>	NAD		
<b>Asbestos type(s):</b>	NAD

<b>Product Type:</b>	0 Non ACM	<b>Accessibility:</b>	
<b>Surface:</b>		<b>Position:</b>	
<b>Condition:</b>		<b>Friability:</b>	
<b>Abs Type:</b>	0 No Asbestos Detected	<b>RISK:</b>	<b>NONE</b>

Note: the component was found not to be an ACM.

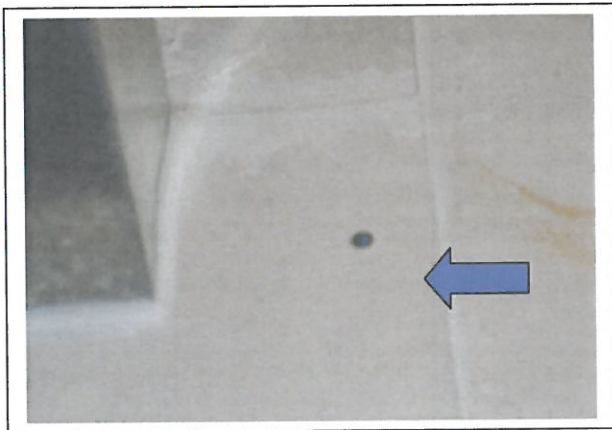
Gas Intake Room Panel fixed to the panel to frame above the door.

Inspection Dates:	09 - 10 - 2015	Reference No.:	Sample 07
Surveyors:	AR + PF	Survey Type:	Management Survey
Component:	Panel to provide Fire resistance	Approx Amount:	NA
Asbestos?	NAD		
Asbestos type(s):	NAD

Product Type:	0 Non ACM	Accessibility:	
Surface:		Position:	
Condition:		Friability:	
Abs Type:	0 No Asbestos Detected	RISK:	<b>NONE</b>

Note: the component was found not to be an ACM.

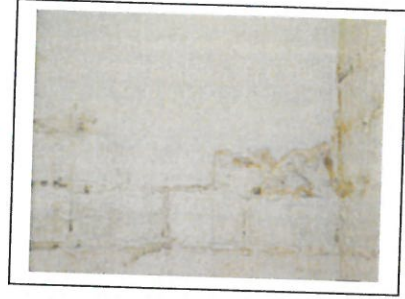
Walls brickwork showing signs of efflorescence

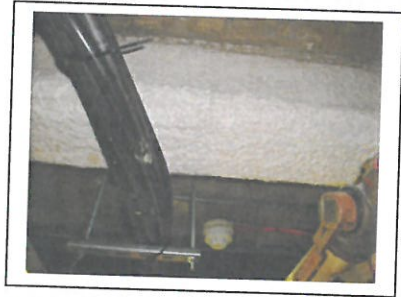
Steel Beams covered with fire protection
