ASBESTOS REINSPECTION REPORT

| Site | St Dunstan's OpCo Ltd , 20 St. Dunstan's Hill, London,, EC3R 8HL |
| Date report issued | 21st March 2023 |
| Survey reference | J853079 |

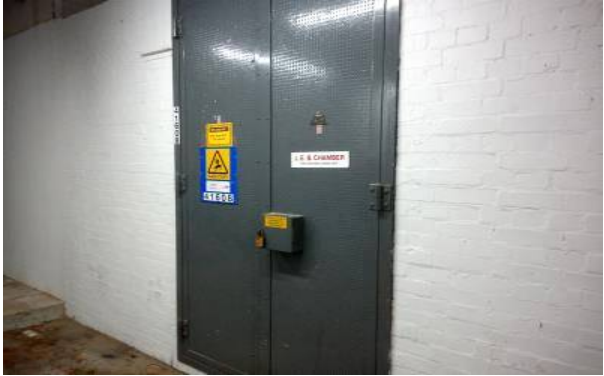
| Item / Inspection Ref: | #1 | Material Assessment | Product type: | | |

| Building | Main Building | | | | | | | | | Room Notes |
|---|---|---|---|---|---|---|---|---|---|---|
| Z-Sub Level 1 | front lightwell | #1 | cement panels | durasteel doors | No Asbestos Detected | | | None required | | |

| Item Description: | cement panels | | Number of Occupants: | N/A | |
| RISK CODE: | No Asbestos | Frequency of Maintenance: | N/A | | |

| Action: | None required | | Time in Area: | N/A | |

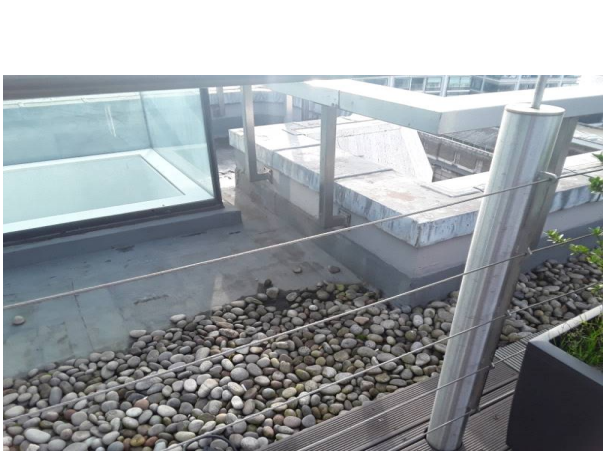
| Item / Inspection Ref: | #2 | Material Assessment | Product type: | 3 | |

| Building | Main Building | | | | | | | | | Room Notes |
|---|---|---|---|---|---|---|---|---|---|---|
| External | External building | #2 | Parapet lining | Walls | Amosite | 150lm | C | Monitor and manage | Encapsulated | Reinspection survey only. |

| Item Description: | Parapet lining | | Number of Occupants: | N/A | |
| RISK CODE: | C | Frequency of Maintenance: | N/A | | |
| Comments: | No change 15/03/23 | Total Score: | 6 | Material Status Change: | |
| | | | | Encapsulated | |

| Action: | Monitor and manage | | Time in Area: | N/A | |
