# **Fire Risk Assessment**

Haryl (1991) Ltd
Common areas only within
Spencer House
3 Spencer Parade
Northampton
NN1 5AA

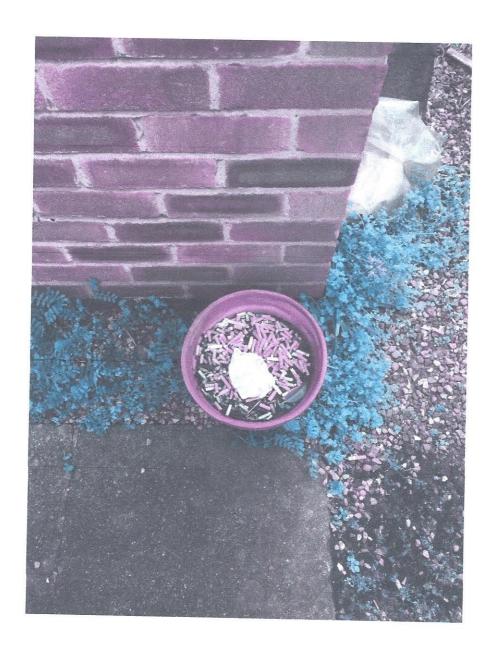
Photo 1

8.2. It is recommended that the ceramic plant pot used to dispose of old cigarettes be emptied on a regular basis (see photo 1) to avoid overfilling and potential fire risk. Ideally an enclosed cigarette bin should be proved and maintained regularly.

required.	T	T
	Recommend review.		
8.2.	It is recommended that the ceramic plant pot used to dispose of old cigarettes be emptied on a regular basis (see photo 1) to avoid overfilling and potential fire risk. Ideally an enclosed cigarette bin should be proved and maintained regularly. Recommend revise and review.	Actioned by cleaner.

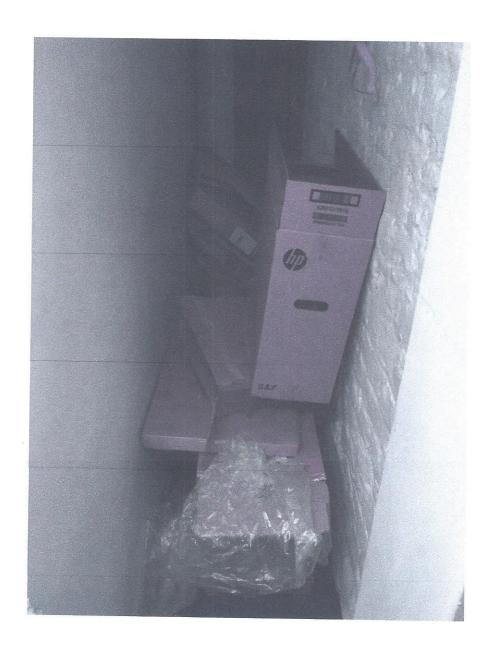
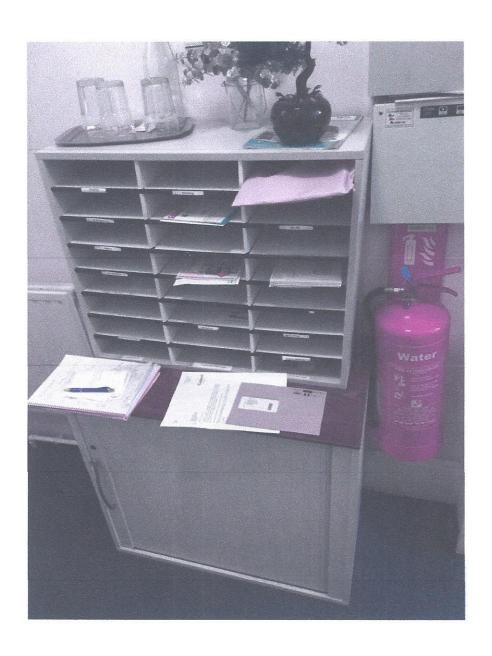
10.2 + 10.3. It is recommended that the storage of combustible materials kept within the basement lobby and upon the ground floor lobby areas be removed. Ideally the escape routes leading from the building should be kept free from combustible materials at all times (see photos 2 + 3).

10.2 + 10.3.	10.2 + 10.3. It is recommended that the storage of combustible materials kept within the basement lobby and upon the ground floor lobby areas be removed. Ideally the escape routes leading from the building should be kept free from combustible materials at all times (see photos 2 + 3). It is also advised that the storage of items left inside the basement boiler room be removed and stored elsewhere away from any potential ignition sources (see photo 4). Ideally storage of items within the basement should be kept to a bare minimum.	Mark to remove t ticky

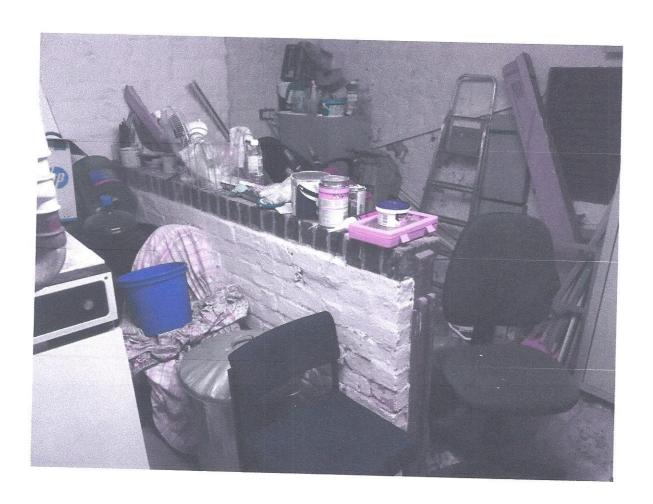
Photo 4

It is also advised that the storage of items left inside the basement boiler room be removed and stored elsewhere away from any potential ignition sources (see photo 4). Ideally storage of items within the basement should be kept to a bare minimum.

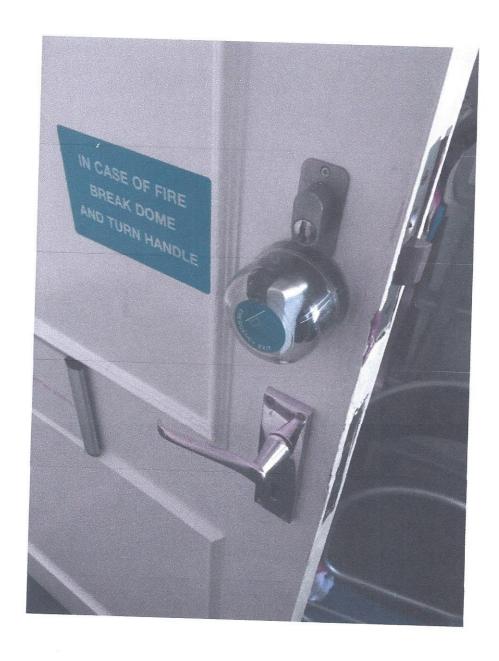
It was also noted that the rear fire escape route signed to exit through room 11 may need to be altered. Upon inspection the door to room 11 has been fitted with a break glass device which will enable people to open the door via the protected thumb turn lock (see photo 5). This alone would

Potin welcome pack pack hotorie opotorie pegs be adequate but the door has also been fitted with a second mortise lock which if locked will stop anyone from opening the door and having further access to the final fire exit. Either the mortise locking device is removed to eliminate this risk or the fire exit route is changed using only the single fire exit located at the top of the corridor. If the exit route is to change then all signage indicating the old escape route should be removed and new fire exit directional signage should be installed instead.

11.2 + 11.9.	It is recommended that the fire escape route leading from the rear of the building be reviewed.  When using the side fire exit which leads to the outside of the building it wasn't immediately obvious that the key positioned beside the door needed to be taken from the key box to gain further access from the rear courtyard. A locked back door and a further locked gate need to be passed through to gain access to the side street where it is then possible to walk around to the fire assembly point located at the front of the building. This means of escape is not ideal as it could prove difficult to see the key	In welcome pack. No visitors out of hours, inaccopanied

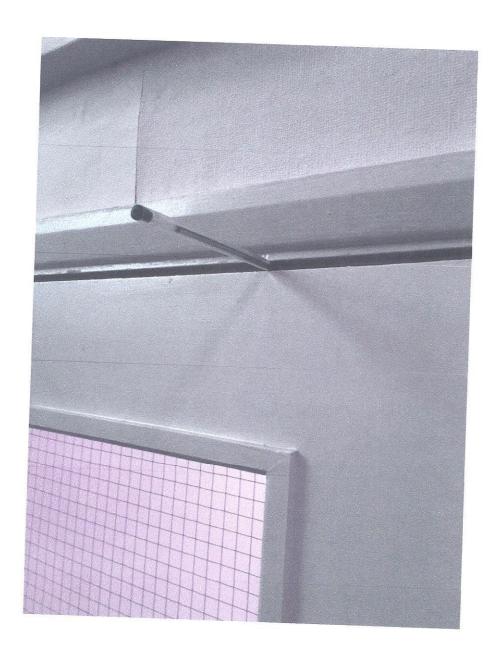
12.2. It was noted that some fire doors inside the building were missing their third fire rated hinges and also have large gaps visible around the top of the door (see photo 6). It is recommended that all missing parts be installed and adjustments be carried out to doors with gapping as soon as possible by a qualified company and as to requirements of current British standards. This will ensure that the doors work correctly if subjected to a threat of fire.

12.2.	It was noted that some fire doors inside the building were missing their third fire rated hinges and also have large gaps visible around the top of the door (see photo 6). It is recommended that all missing parts be installed and adjustments be carried out to doors with gapping as soon as possible by a qualified company and as to requirements of current British standards. This will ensure that the doors work correctly if subjected to a threat of fire.	URGENT,
