The Regulatory Reform Order (Fire Safety) Order 2005

Fire Risk Assessment

Haryl (1991) Limited
Common Areas Only
Becketts House
14 Billing Road
Northampton
NN1 5AW

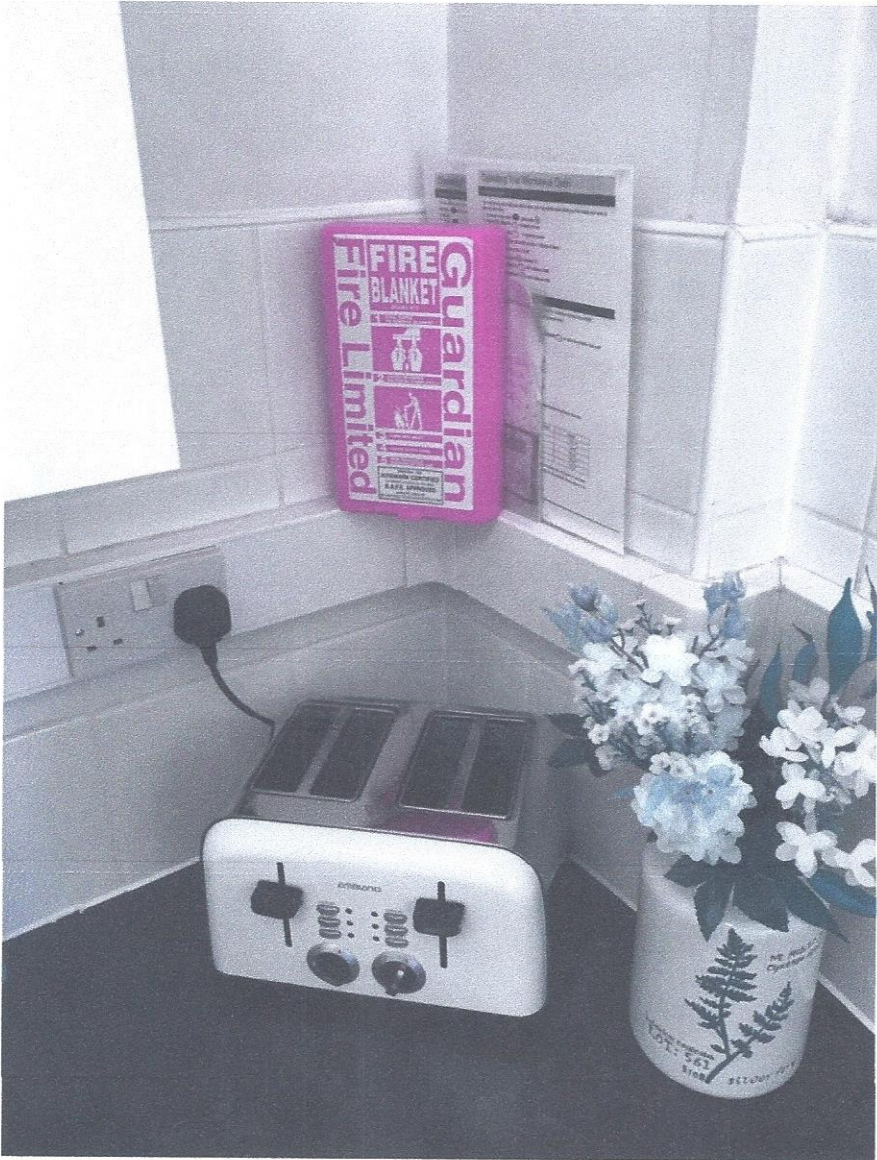
Photo 1

6.10. It was noted that someone had placed the second fire blanket directly above the toaster (see photo 1) it was recommended that this and the paperwork kept behind be removed straight away.

6.10.	<p>It was noted that someone had placed the second fire blanket directly above the toaster (see photo 1) it was recommended that this and the paperwork kept behind be removed straight away.</p> <p>Recommend revise and review</p>	<p>Action Imm.</p>	<p>✓</p>

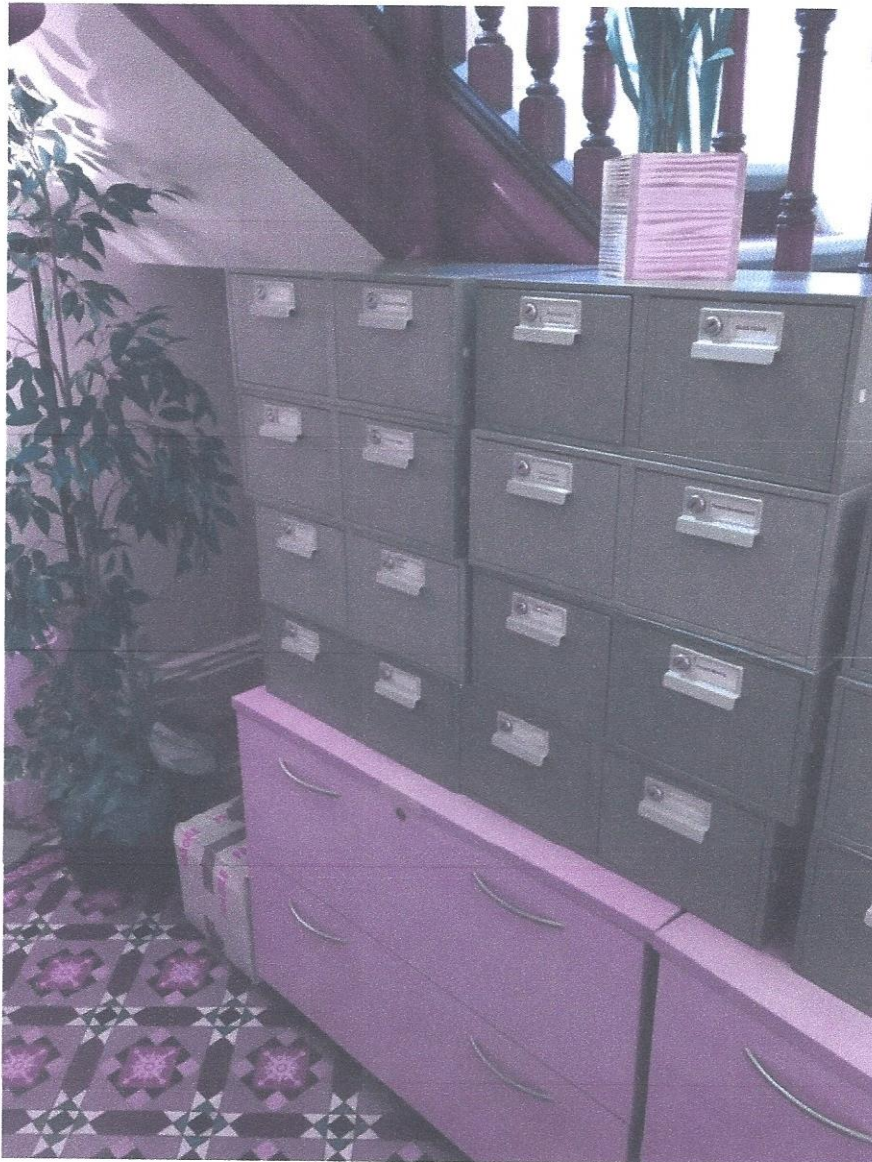
Photo 2

10.1 – 10.3. It is recommended that the storage of combustible materials kept within the 2nd floor and ground floor lobby areas be removed. Ideally the escape routes leading from the building should be kept free from combustible materials at all times (see photos 2).

10.1 - 10.3.	<p>It is recommended that the storage of combustible materials kept within the 2nd floor and ground floor lobby areas be</p>	<p>nothing on 2nd Floor.</p>	<p>✓</p>

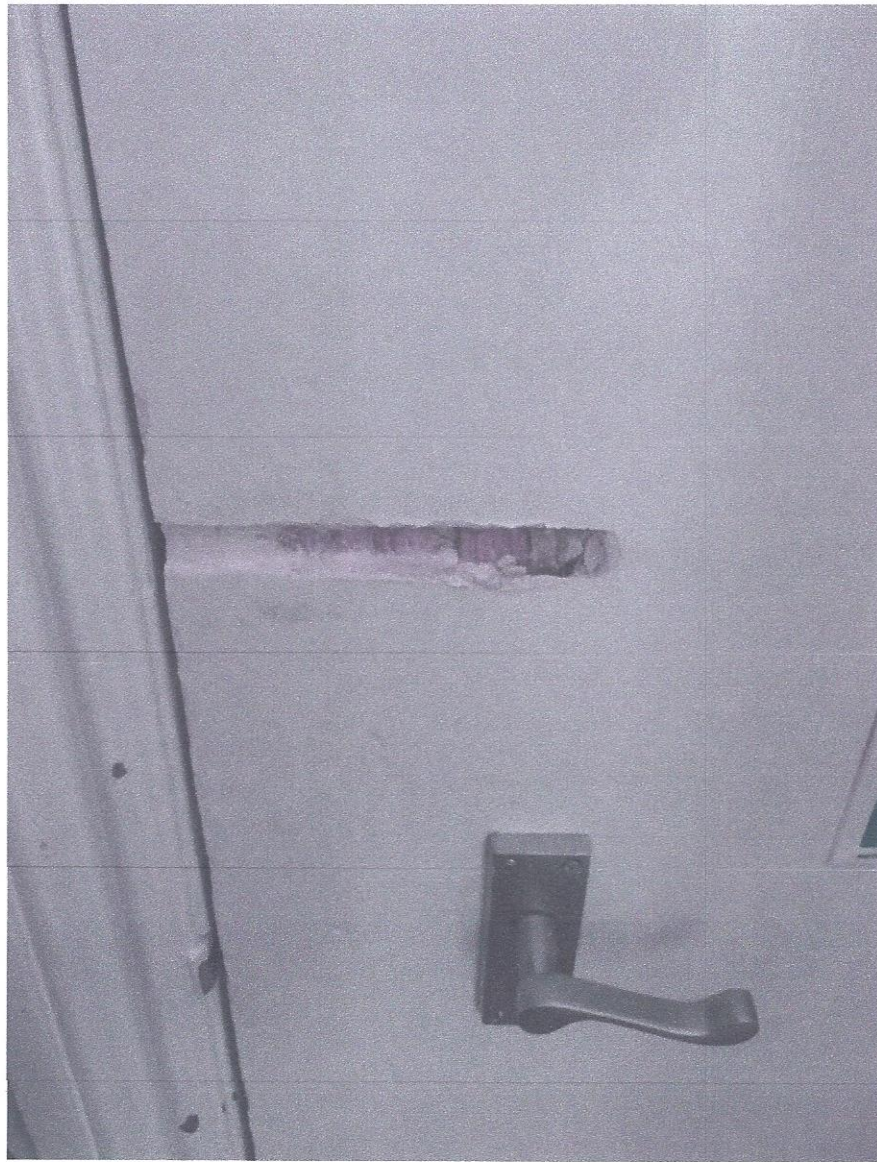
Photo 5

★ 12.2 + 12.4. It is recommended that the all fire doors fitted within the building be subjected to an inspection by a qualified company as soon as possible. Many fire doors fitted either have large gaps visible around the door or are missing their third fire rated hinges (see photo 4). The fire door behind reception to the rear stairwell has also suffered damage at some point and will need to be replaced (see photo 5).

12.2 + 12.4.	<p>It is recommended that the all fire doors fitted within the building be subjected to an inspection by a qualified company as soon as possible. Many fire doors fitted either have large gaps visible around the door or are missing their third fire rated hinges (see photo 4). The fire door behind reception to the rear stairwell has also suffered damage at some point and will need to be replaced (see photo 5).</p> <p>Recommend revise and review.</p>	<p>Action ASAP SH + BH.</p>	<p>Done</p>

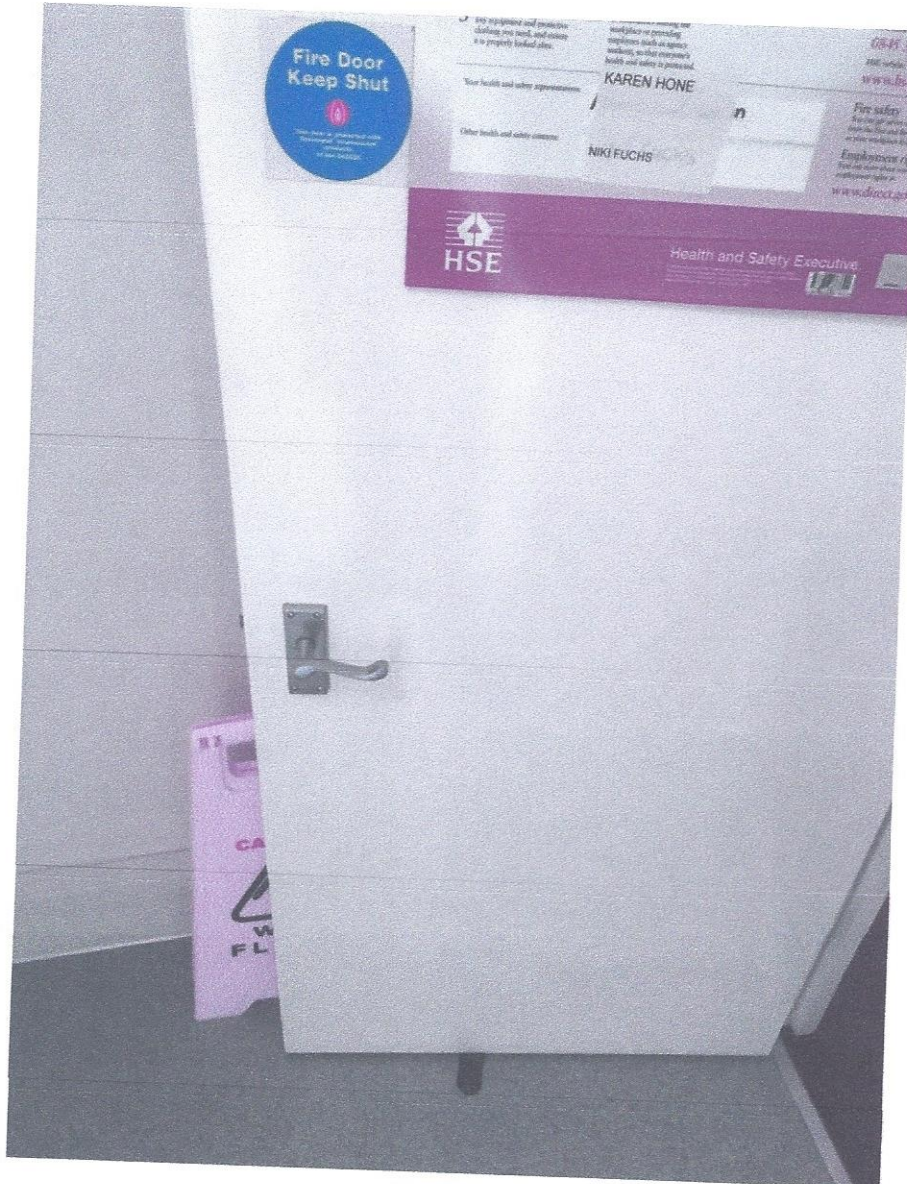
Photo 6

12.9. It is recommended that all fire doors are kept shut when not in use and never propped open as they can only prevent the spread of fire and smoke if kept closed. Staff should remove any door stops when found (see photo 6).

<p>12.9.</p>	<p>It is recommended that all fire doors are kept shut when not in use and never propped open as they can only prevent the spread of fire and smoke if kept closed. Staff should remove any door stops when found (see photo 6).</p>	<p>This is mgd daily</p>
