ASBESTOS MANAGEMENT SURVEY REPORT AND ASBESTOS RE-INSPECTION REGISTER Based on a Type 2 Survey

Site Address: Beckett House, 14 Billing Road, Northampton , NN1 5AW
Survey Date: 21st April 2004
Survey Ref: J04822
Updated: 16th July 2018
Register Ref: J089121
Client: HARYL (1991) Limited, Beckett House, 14 Billing Road, Northampton,
NN1 5AW
Prepared By: Leanne Bason

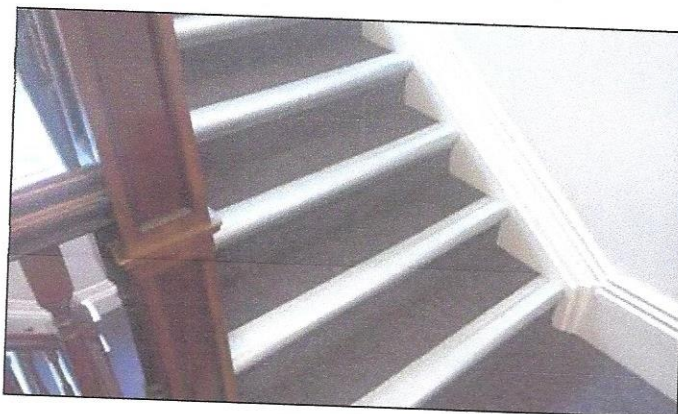
Sample No.	B10 {AF002758}	Description	Resin stair nosings
-------------------	----------------	--------------------	---------------------

Location ID	001	Position	to the stairs.		
Building	01 Main Building	Floor	1st Floor	Room/Area	Stairwell (001)
Last Inspection Date	16/07/2018	Next Inspection Date	16/07/2019

Product Type	Resin composites	Extent	30lm		
Surface Treatment	Composite (Self sealed)	HSE Notifiable	Non notifiable non licensed material		
Damage Extent	Low Damage	Accessibility	Occasionally likely to be disturbed		
Asbestos Type	Chrysotile				
Material Risk No.	3	Certificate No.	J089121		
Material Risk	Very Low Risk

Comments	The ACM was re-inspected by Ensaf Consultants on the 16/07/2018, it was found to be still in the same condition. Area was labelled.
Recommendations	The material was in a generally good condition and should therefore be managed, it may be prudent to consider labelling where necessary

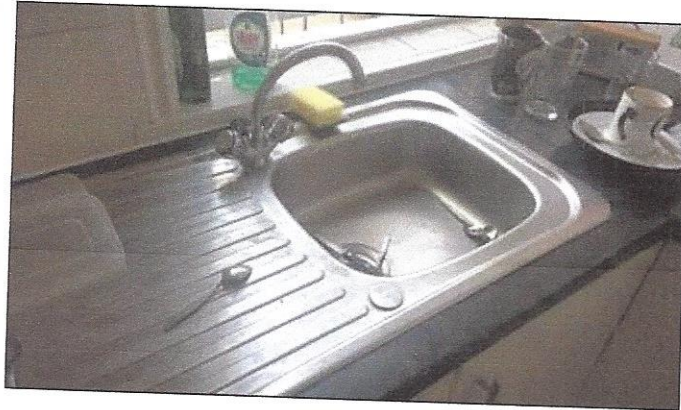
Sample No.	B12 {AF002759}	Description	Mastic pad
-------------------	----------------	--------------------	------------

Location ID	002	Position	to the underside of the metal sink.		
Building	01 Main Building	Floor	1st Floor	Room/Area	Kitchen (002)
Last Inspection Date	16/07/2018	Next Inspection Date	N/A

Product Type	Removed	Extent	<1m ²
Surface Treatment	Composite (Self sealed)	HSE Notifiable	Non notifiable non licensed material
Damage Extent	Good Condition	Accessibility	Usually inaccessible or unlikely to be disturbed
Asbestos Type	Removed		
Material Risk No.	0	Certificate No.	J089121
Material Risk	NO ASBESTOS DETECTED

Comments	The ACM was reinspected on the 16/07/18 by Ensaf Consultants and sink unit was found to have been removed and replaced by an unknown contractor on an unknown date.
Recommendations	No further action required

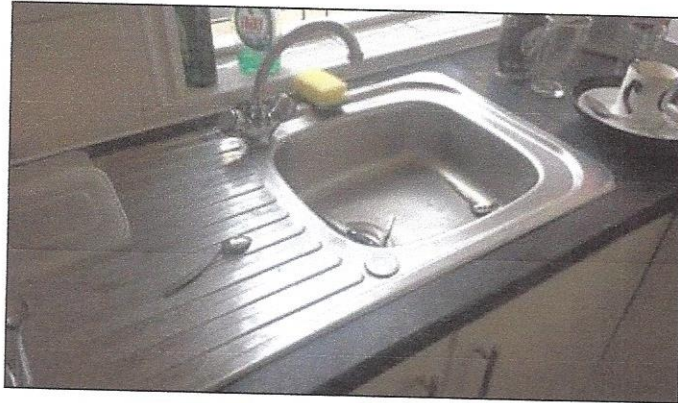
Sample No.	AF002760	Description	Mastic pad
-------------------	----------	--------------------	------------

Location ID	002	Position	to the underside of the metal sink.		
Building	01 Main Building	Floor	1st Floor	Room/Area	Kitchen (002)
Last Inspection Date	16/07/2018	Next Inspection Date	N/A

Product Type	Mastic pad	Extent	1no.
Surface Treatment	Composite (Self sealed)	HSE Notifiable	Non notifiable non licensed material
Damage Extent	Low Damage	Accessibility	Usually inaccessible or unlikely to be disturbed
Asbestos Type	No Asbestos Detected		
Material Risk No.	0	Certificate No.	J089121
Material Risk	NO ASBESTOS DETECTED

Comments	An additional sample was taken by Ensafe Consultants during reinspection on the 16/07/2018.
Recommendations	No further action required

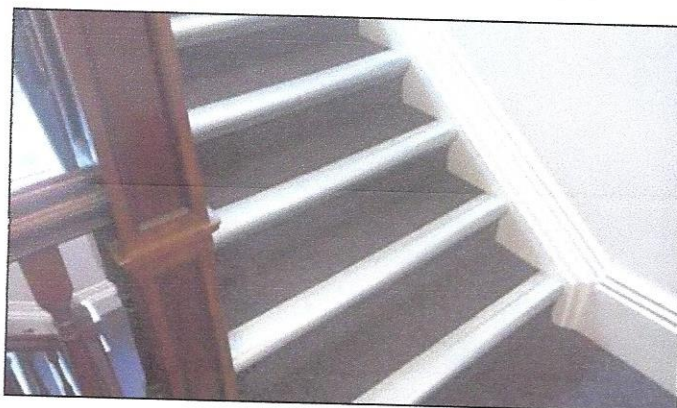
HARYL (1991) Limited				
UPRN			Building	01 Main Building
Site	Beckett House, 14 Billing Road, Northampton		Floor	1st Floor
Location	001	Room/Area	Stairwell (001)	
Sample No	B10 {AF002758}	Description	Resin stair nosings to the stairs.	Extent 30lm

Product Type	Resin composites	Surface Treatment	Composite (Self sealed)
Asbestos Type	Chrysotile	Damage Extent	Low Damage

Occupancy Activity	Location	Accessibility
Low disturbance	Rooms up to 100m ²	Occasionally likely to be disturbed
Extent of Material	No. of Occupants	Frequency of Use
10m ² - 50m ² or 10m - 50m pipe run	>10	Daily
Average Time	Maintenance Activity	Frequency of Maintenance
1 to 3 hours	Minor disturbance	Unlikely

MA Score	PA Score	Overall Risk Score	Overall Risk Category	Recommended Action
3	6	9	Low Risk	The material was in a generally good condition and should therefore be managed, it may be prudent to consider labelling where necessary
Comment				The ACM was re-inspected by Ensaf Consultants on the 16/07/2018, it was found to be still in the same condition. Area was labelled.
