**Asbestos Survey undertaken at  
20 Little Britain  
London  
EC1A 7DH**

Survey type: **Management survey**

Asbestos Survey Report: Management

**20 Little Britain  
London  
EC1A 7DH**

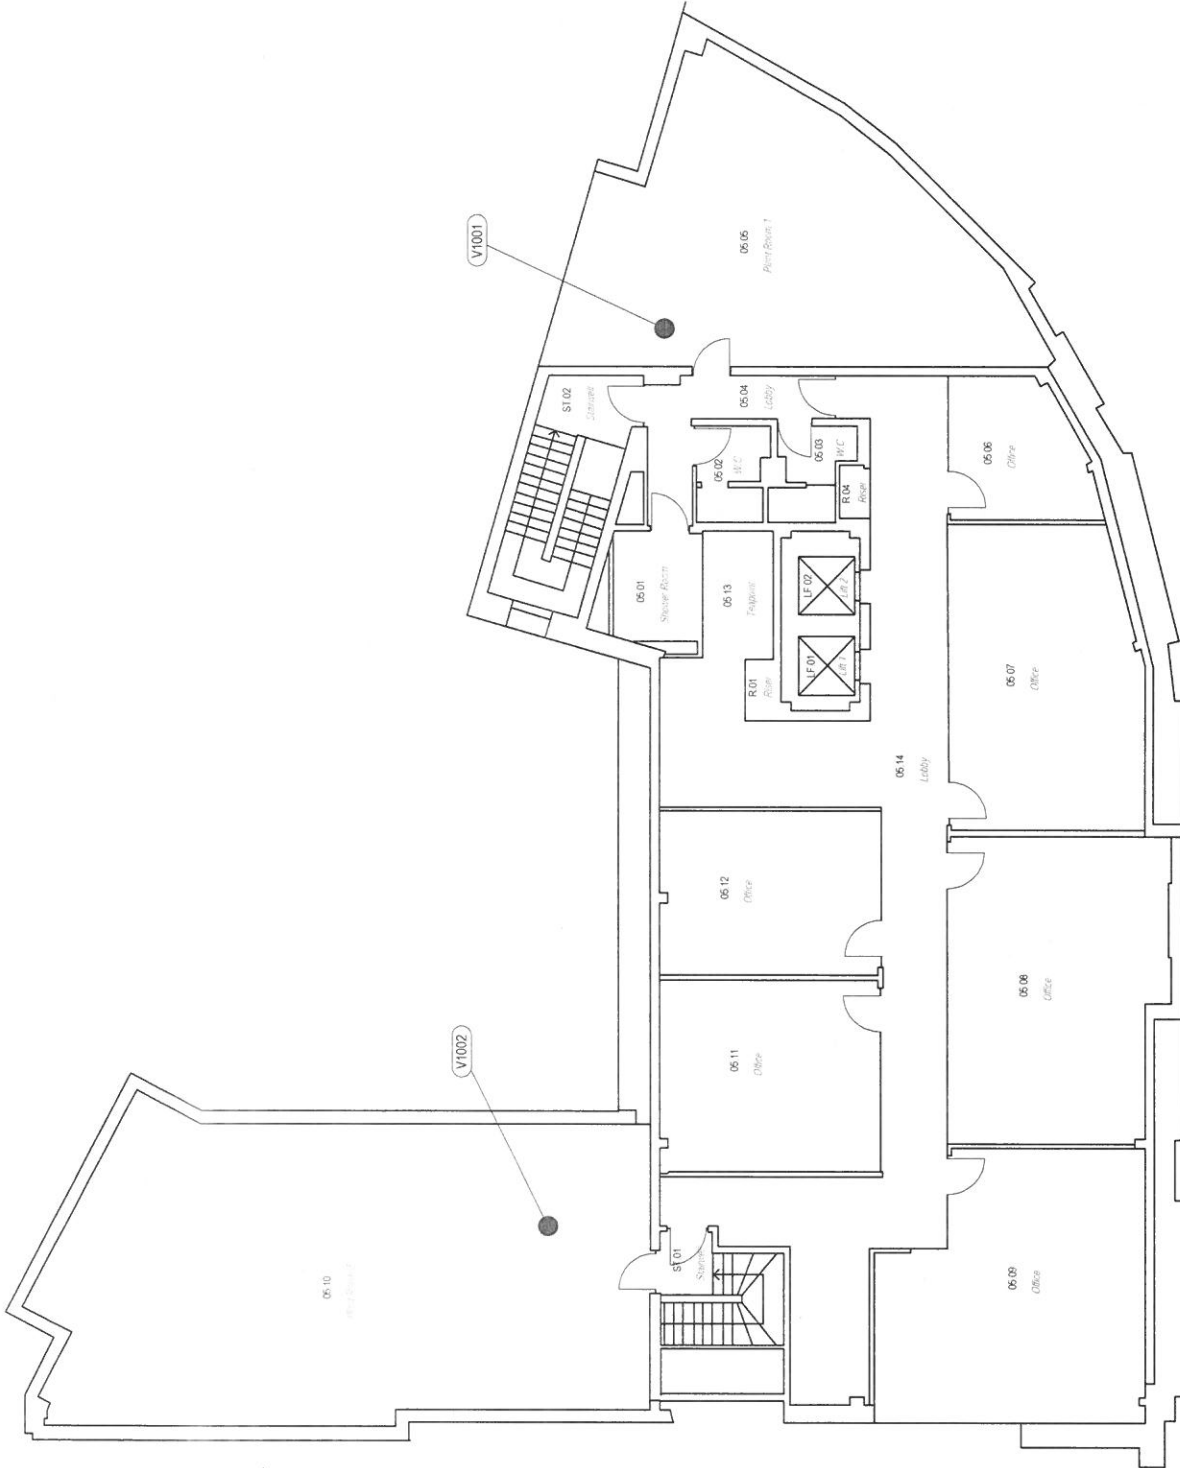
Sample Number	Visual Number	Area Number	Area_Use	Sample/Visual_Comments	Product_Type	Damage	Surface_Treatment	Location	Accessibility	Quantity	Analysis Result	Priority Rating
V0102/1001	05.05	Plant Room 1		Gasket to pipework.	Gasket	Good condition	Gasket	Internal	Moderate	<1m2	Presume Chrysotile	Very Low
<b>Recommended Action:</b> Manage												
<b>Comments:</b> Manage & Monitor in situ.												
V0102/1002	05.10	Plant Room 2		Gasket to pipework.	Gasket	Good condition	Gasket	Internal	Moderate	<1m2	Presume Chrysotile	Very Low
<b>Recommended Action:</b> Manage												
<b>Comments:</b> Manage & Monitor in situ.
