RISK ASSESSMENT HOT & COLD WATER SERVICES

St Dunstons Opco Ltd
20 St Dunstons Hill
London
EC3R 8HL

Undertaken by Daniel Coree of Phase Technology

Survey Date: 9th February 2023

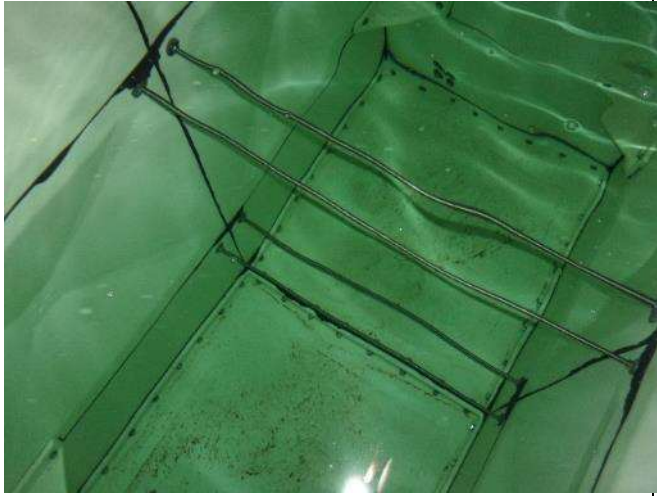
Tank External	Tank Internal

Cold water storage tanks considered to be a risk, HSG 274.
Potable tank identified (drinking water) and no testing regime was observed.

Ensure tank is inspected every 6 months (12 months for non-potable).
Establish bi-annual testing regime of the tank for TVCs and Pseudomonas Aeruginosa.

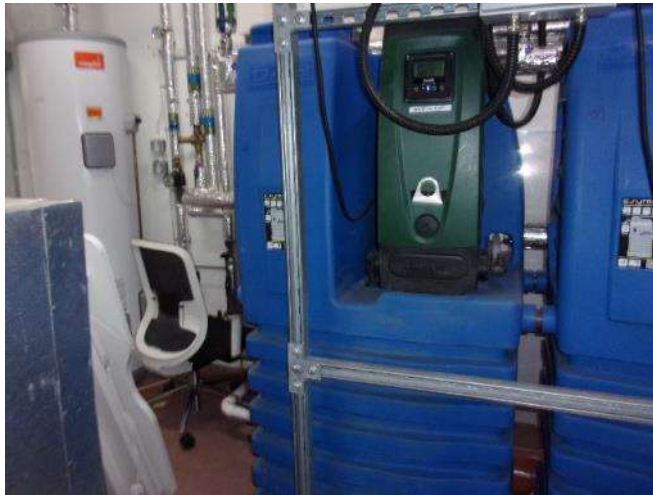
Tank External

COMMENTS
Cold water storage tanks considered to be a risk, HSG 274. Potable tank identified (drinking water) and no testing regime was observed.

RECOMMENDATIONS
Ensure tank is inspected every 6 months (12 months for non-potable). Establish bi-annual testing regime of the tank for TVCs and Pseudomonas Aeruginosa.

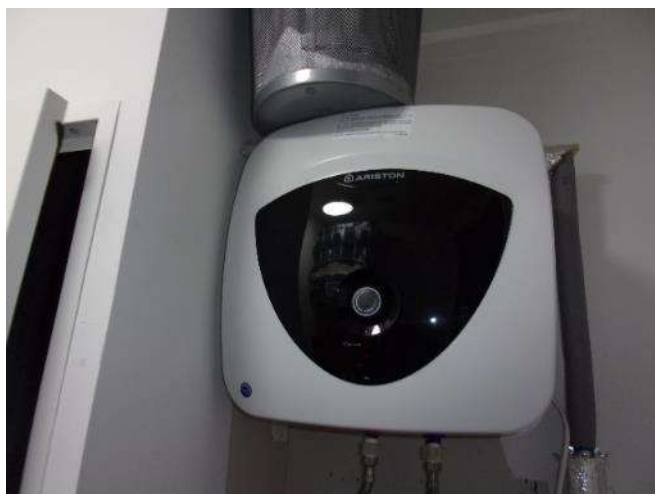
Technical Data	
Asset reference	High Volume Water Heater
Make	Ariston
Location	3F Cleaners Cupboard – Representative of 4F Cleaners Cupboard
Risk Assessment Data	
Pipework Insulated	Yes
Size in litres	30L
Storage Temperature (60 °C Min)	46.0

RISK RATING HIGH

COMMENTS
<p>High volume water heater considered to be a risk, HSG 274.</p> <p>Stored water temperature too low (less than 60 °C).</p>

RECOMMENDATIONS
<p>Increase water heater storage temperature to 60 °C.</p>

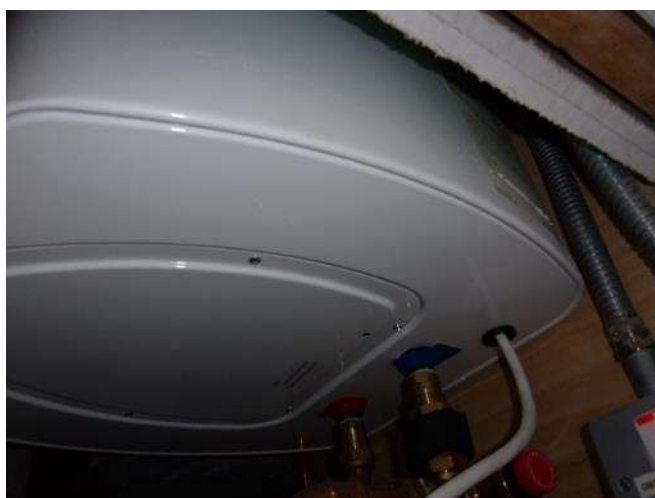
RISK RATING MEDIUM

COMMENTS
High volume water heater considered to be a risk, HSG 274.

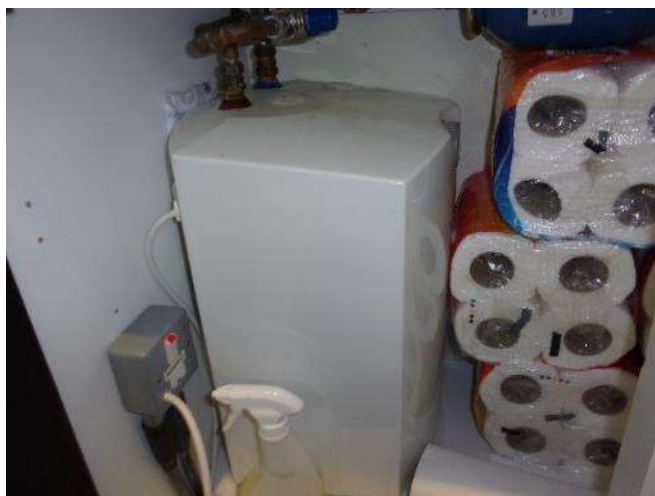
RISK RATING LOW

COMMENTS
Low volume water heater (15 litres or less) considered to be low risk in normal operation, HSG 274.

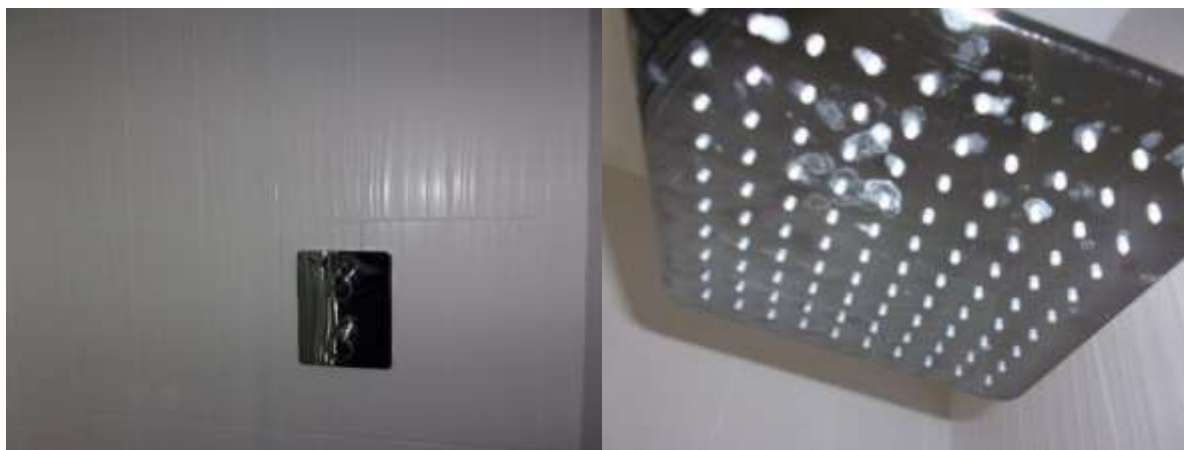
RISK RATING HIGH

COMMENTS
<p>This is considered a risk system as defined in the ACoP L8.</p> <p>Light scale deposits present to shower.</p> <p>Although we were informed that these outlets are flushed, no records were seen on site.</p>

RECOMMENDATIONS
<p>Clean and descale outlet. Ensure a regular cleaning programme is in place to minimise the risk of microbial proliferation.</p> <p>Flush weekly during low periods of use or low occupation. Record all actions.</p>

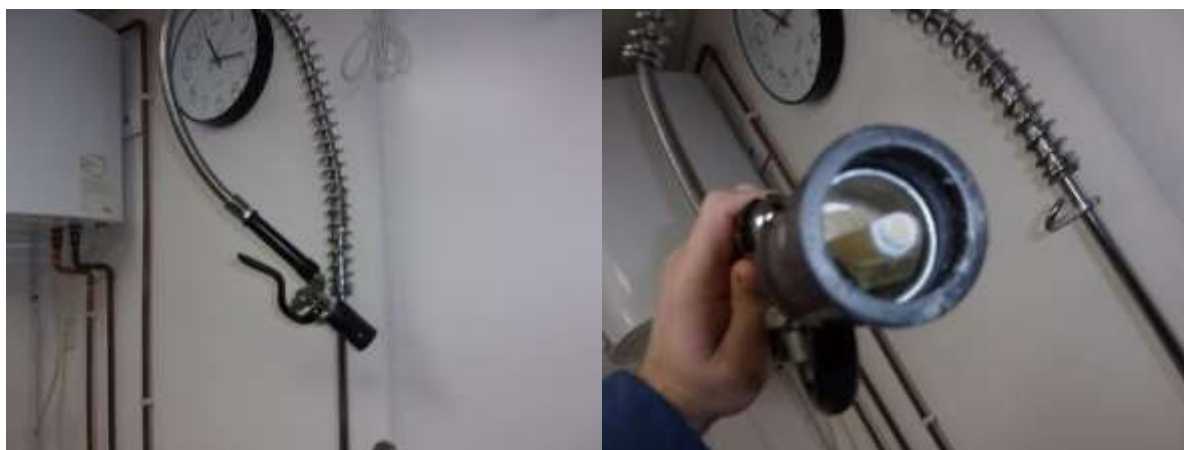
RISK RATING MEDIUM

COMMENTS
 This is considered a risk system as defined in the ACoP L8.

RECOMMENDATIONS
 Ensure it is in regular use and clean/de-scale at least quarterly.

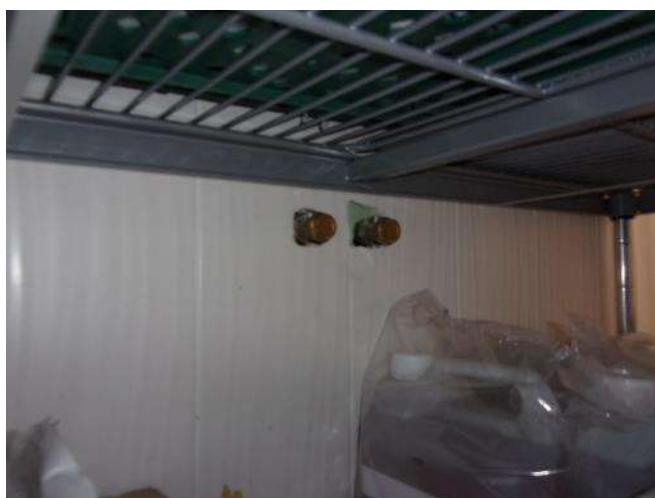
Technical Data	
System Type	Deadend 1
Location	LGF Old Accessible Toilet (Now Store)
System Serves	Removed Outlets
System Fed from	UNKNOWN and CWST 1
Risk Assessment Data	
Size	15mm x Unknown (Hot and Cold Supplies)
Risk Rating High/Medium	High

RISK RATING HIGH

We noted a deadend in the pipework and this can lead to an increase in the likelihood that legionella and other bacteria will proliferate in the system.

We recommend that all deadends on site be cut back to the live source.

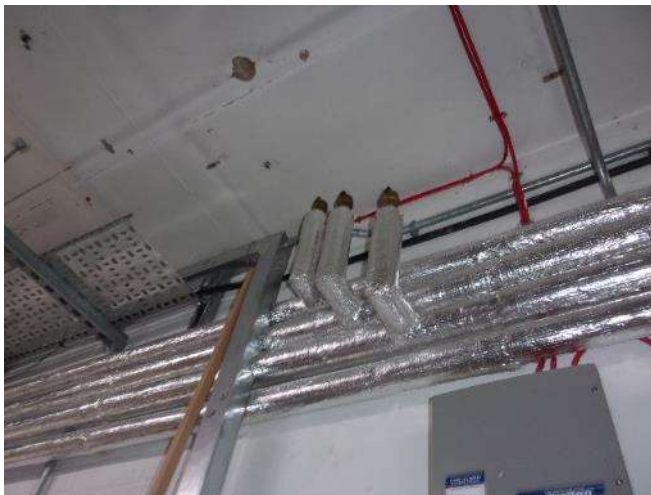
Technical Data	
System Type	Deadleg 4
Location	Basement Plant Room
System Serves	Air Valve x 3
System Fed from	MAINS, CWST 1 and CAL 1
Risk Assessment Data	
Size	15mmx 30cm x 3
Risk Rating High/Medium	Medium

RISK RATING MEDIUM

COMMENTS
The outlet / pipework does not appear to be in regular use and therefore forms an effective deadleg in the system. This can lead to an increase in the likelihood that legionella and other bacteria will proliferate.

RECOMMENDATIONS
Flush weekly and record actions.

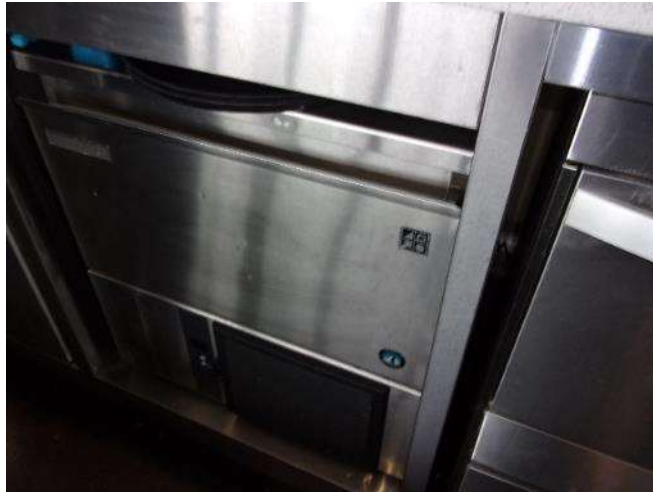
Technical Data	
System Type	Ice Making Machine
System Reference	ICE
Location	Roof Servery

RISK RATING MEDIUM

Ice should not be allowed to stagnate in the machine's storage bin but should be changed frequently.
All machines should be cleaned regularly in accordance with the manufacturer's recommendations.

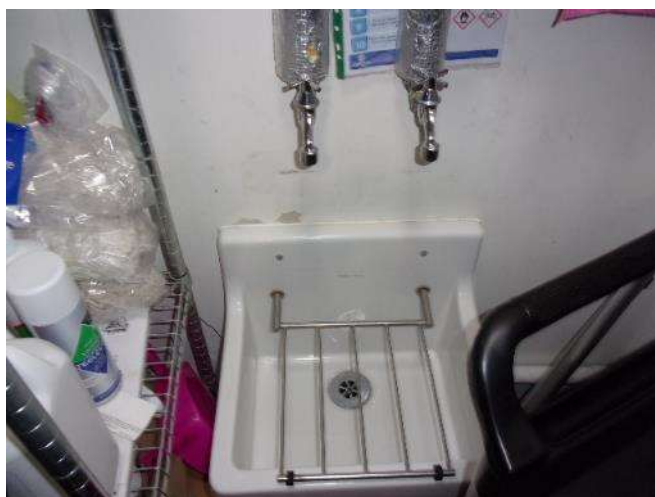
Technical Data	
System Type	Butler Sink/High Drop Sink
System Reference	BSK
Location	See asset table for locations
System Fed from	EWH 30L and CWST 1
Risk Assessment Data	
Potential aerosol formation	Potential spray in operation
Outlet Condition	Trace Scale

RISK RATING MEDIUM

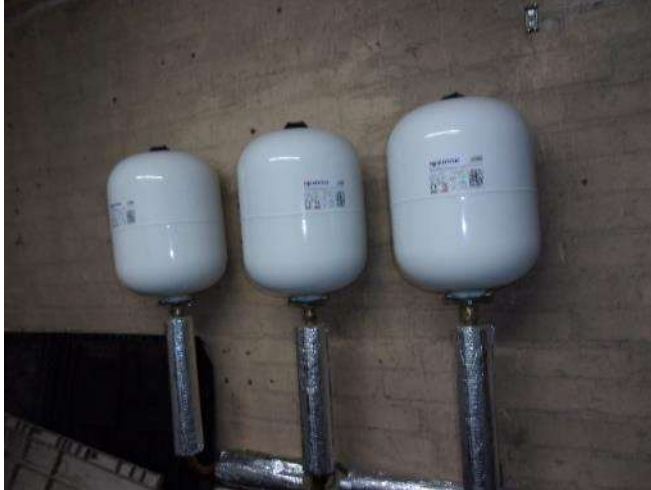
Location	External Bin Store
Service/Equipment supplied	CAL 2

RISK RATING HIGH

COMMENTS
It is not clear why these vessels have been installed on the secondary return and why there are three of them. We would not traditionally see these on the secondary return and they pose a stagnation risk as they were cold upon inspection.

RECOMMENDATIONS
Investigate why these vessels have been installed in this configuration.

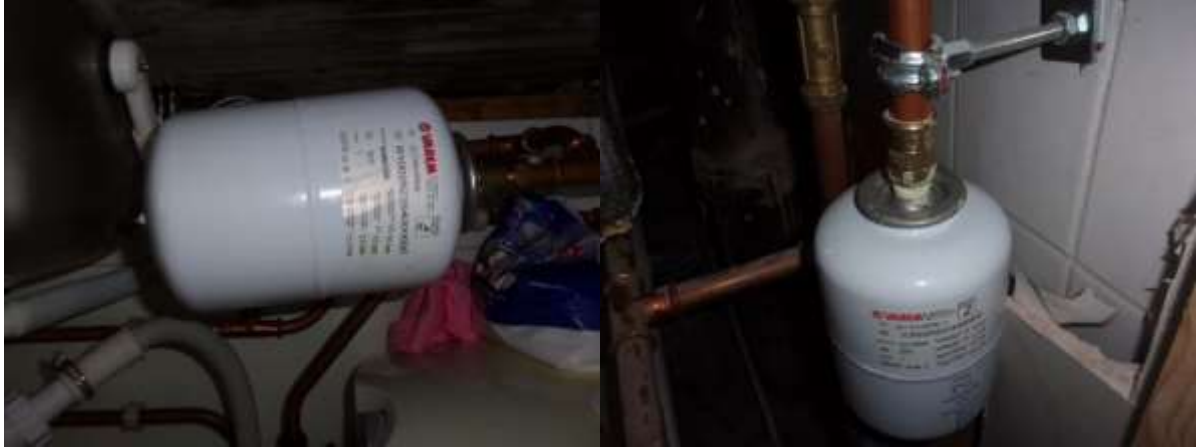
Location	See asset table for locations
Service/Equipment supplied	Electric Water Heaters

RISK RATING MEDIUM

Expansion vessel installed Horizontally / Upside down. Expansion vessels should be installed vertically as per WRAS recommendations, to prevent stagnation and microbial proliferation.
Expansion vessels are often supplied from long pipework legs which can create deadlegs or where pressure is constant.

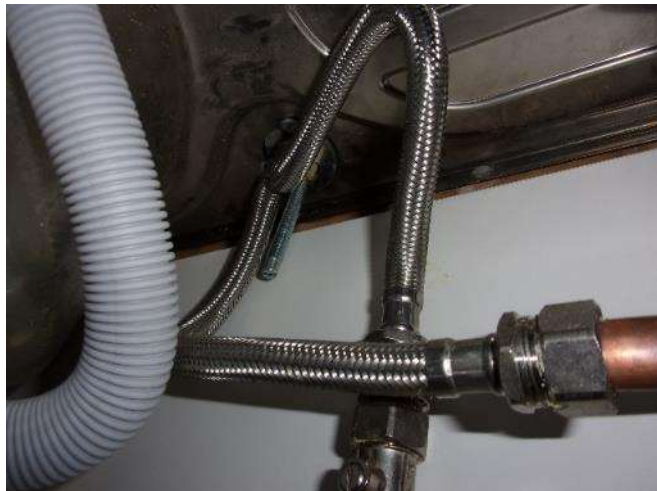
Location	See asset table for locations
Service/Equipment supplied	Standard and potable outlets

RISK RATING LOW

We advise that all non-WRAS approved flexible hoses be replaced with fixed copper connections. If flexible hoses are required due to space restrictions, then WRAS compliant hoses should be fitted.

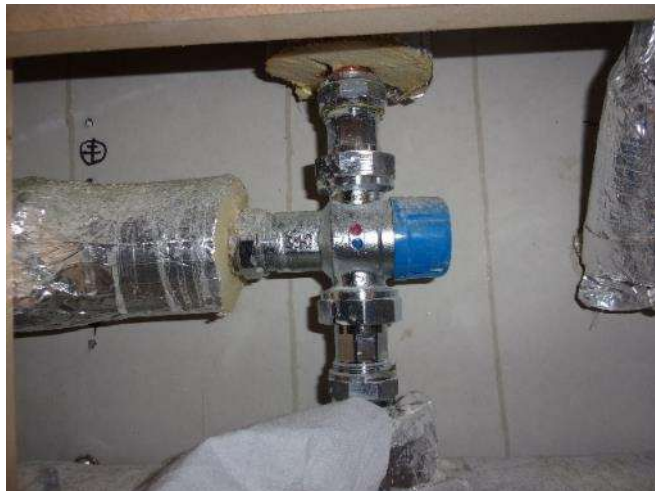
System Type	Thermostatic Mixing Valve
Location	See asset table for locations

RISK RATING MEDIUM

It should be ensured that all TMVs have annual servicing and failsafe checks completed.

There are no records present for annual failsafe checks and servicing.

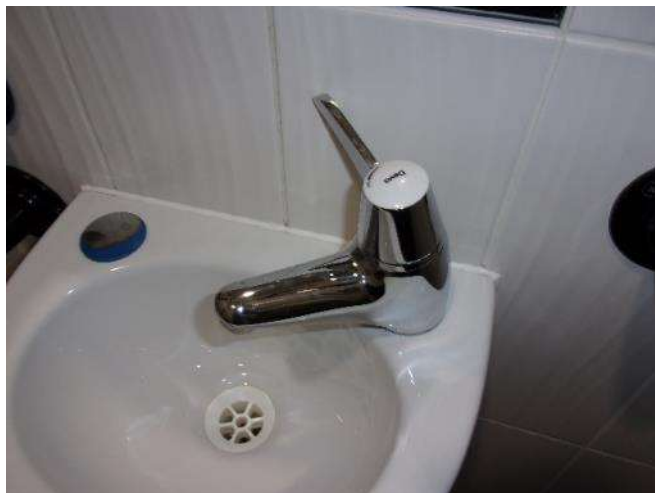
System Type	Thermostatic Mixing Tap
Location	See asset table for locations

RISK RATING MEDIUM

It should be ensured that all TMTs have annual servicing and failsafe checks completed.

There are no records present for annual failsafe checks and servicing.

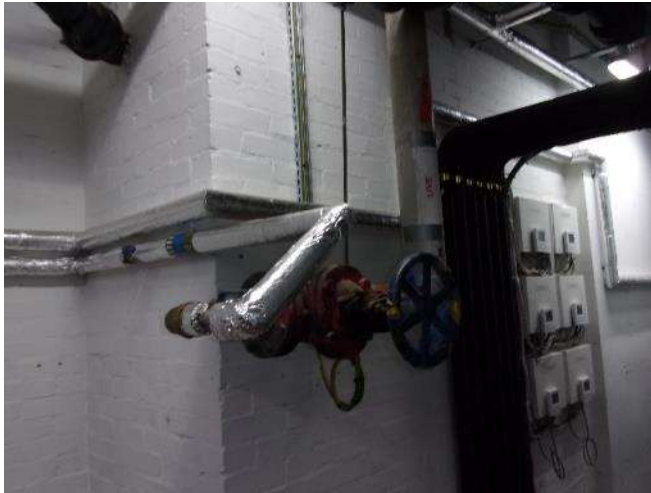
Technical Data	
System Type	Incoming Main
System Reference	ICM
Location	Basement Plant Room
Injection Point Present?	None Seen

RISK RATING LOW
