The Regulatory Reform Order (Fire Safety) Order 2005

Fire Risk Assessment

Haryl (1991) Limited
Common Areas Only
Becketts House
14 Billing Road
Northampton
NN1 5AW

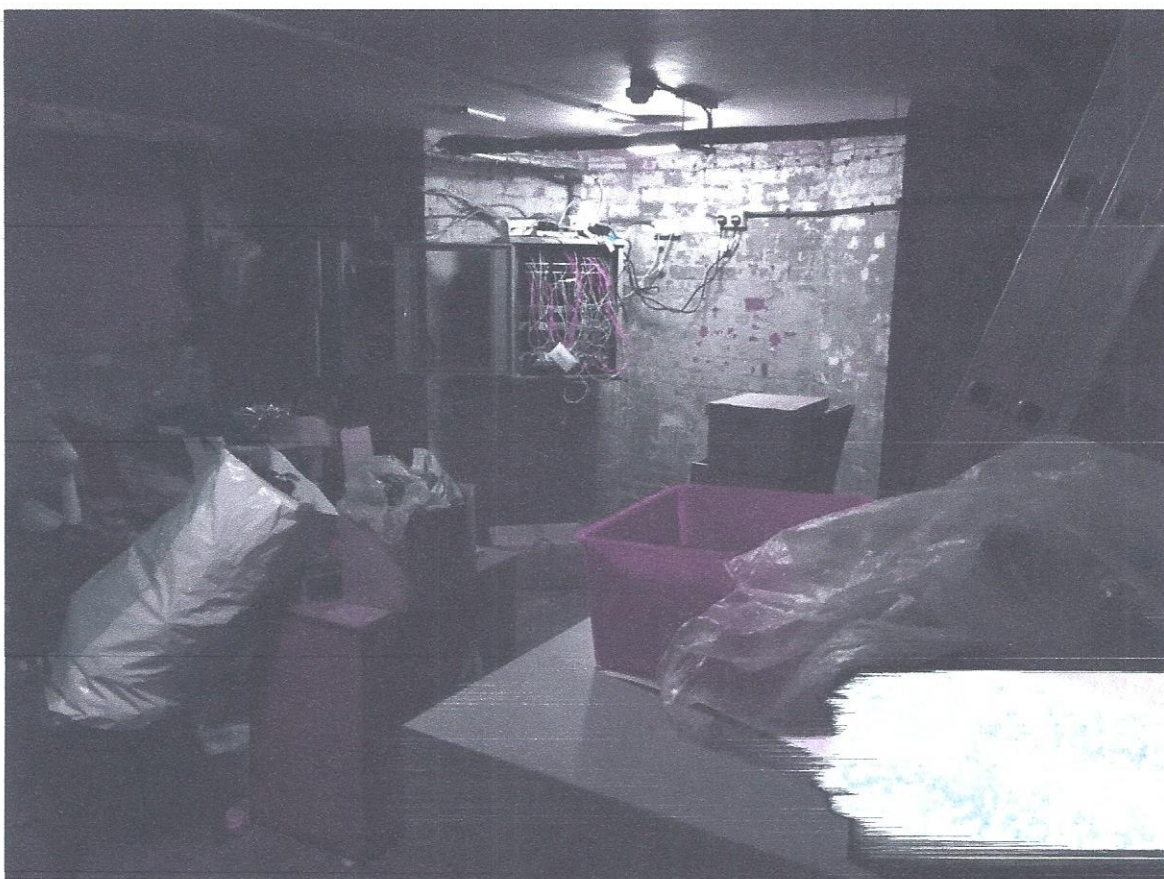
Photo 4

★ 12.2 + 12.4. It is recommended that the all fire doors fitted within the building be subjected to an inspection by a qualified company as soon as possible. Many fire doors fitted either have large gaps visible around the door or are missing their third fire rated hinges (see photo 4). The fire door behind reception to the rear stairwell has also suffered damage at some point and will need to be replaced (see photo 5).

12.2 + 12.4.	<p>It is recommended that the all fire doors fitted within the building be subjected to an inspection by a qualified company as soon as possible. Many fire doors fitted either have large gaps visible around the door or are missing their third fire rated hinges (see photo 4). The fire door behind reception to the rear stairwell has also suffered damage at some point and will need to be replaced (see photo 5).</p> <p>Recommend revise and review.</p>	<p>Action ASAP SH + BH.</p>	<p>Done</p>

12.2 + 12.4.	<p>It is recommended that the all fire doors fitted within the building be subjected to an inspection by a qualified company as soon as possible. Many fire doors fitted either have large gaps visible around the door or are missing their third fire rated hinges (see photo 4). The fire door behind reception to the rear stairwell has also suffered damage at some point and will need to be replaced (see photo 5).</p> <p>Recommend revise and review.</p>	<p>Action Acap SH + BH.</p>
