RISK ASSESSMENT HOT & COLD WATER SERVICES

St Dunstons Opco Ltd
20 St Dunstons Hill
London
EC3R 8HL

Undertaken by Daniel Coree of Phase Technology

Survey Date: 9th February 2023

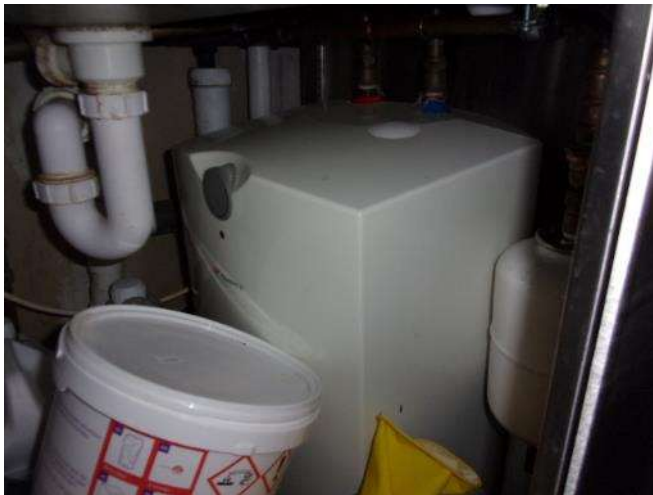
HOT WATER HEATERS

Technical Data	
Asset reference	Low Volume Water Heater
Make	Zip
Location	Roof Servery
Risk Assessment Data	
Pipework Insulated	No – Not Required
Size in litres	15L
Storage Temperature (50 °C Min)	47.0

RISK RATING MEDIUM

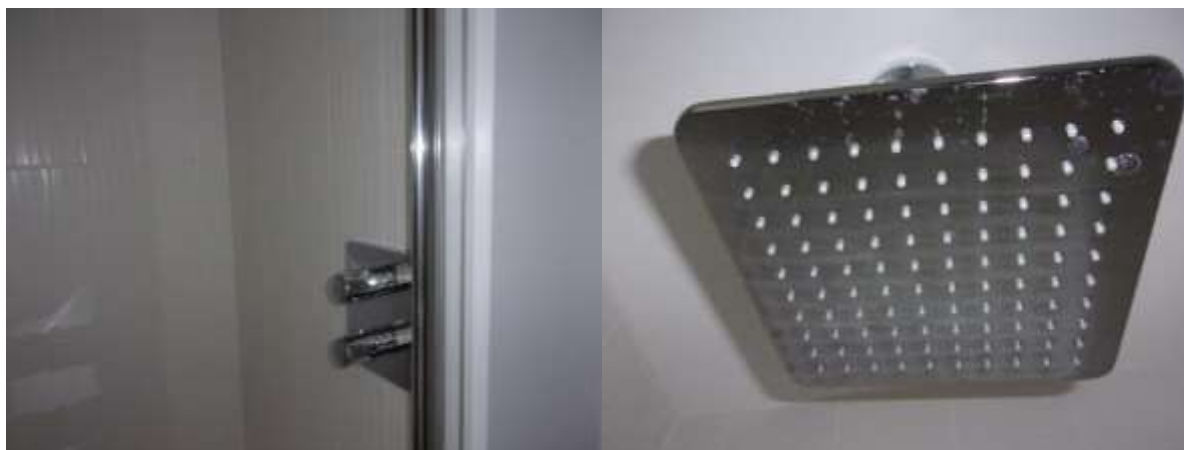
SHOWERS

Technical Data	
Shower Type	Mixer Shower
Location	LGF Illawarra – Representative of GF Port Jackson and GF Harbinger
Shower Fed from	Mains and CAL 1
Risk Assessment Data	
Shower condition	Good
Estimated frequency of use	Little Used – Flushing records not seen
Nature of exposed population	INCREASED SUSCEPTIBITLY , SEE PAGE 2
Degree of exposure	Low (<1 hrs/wk)
Direct Spray Formation	Yes
Dirt / Scale Present	Trace
Biological Slime Present	None
Extent of Corrosion	None

RISK RATING HIGH

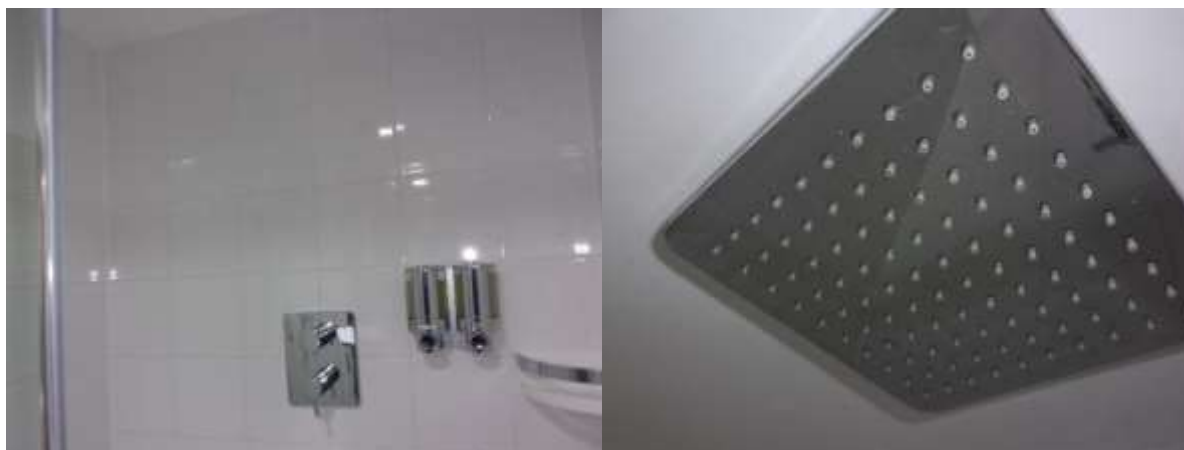
SHOWERS

Technical Data	
Shower Type	Mixer Shower
Location	LGF Shower Room x 6
Shower Fed from	CWST 1 and CAL 2
Risk Assessment Data	
Shower condition	Good
Estimated frequency of use	Little Used – Flushing records not seen
Nature of exposed population	INCREASED SUSCEPTIBLY , SEE PAGE 2
Degree of exposure	Low (<1 hrs/wk)
Direct Spray Formation	Yes
Dirt / Scale Present	Trace
Biological Slime Present	None
Extent of Corrosion	None

RISK RATING HIGH

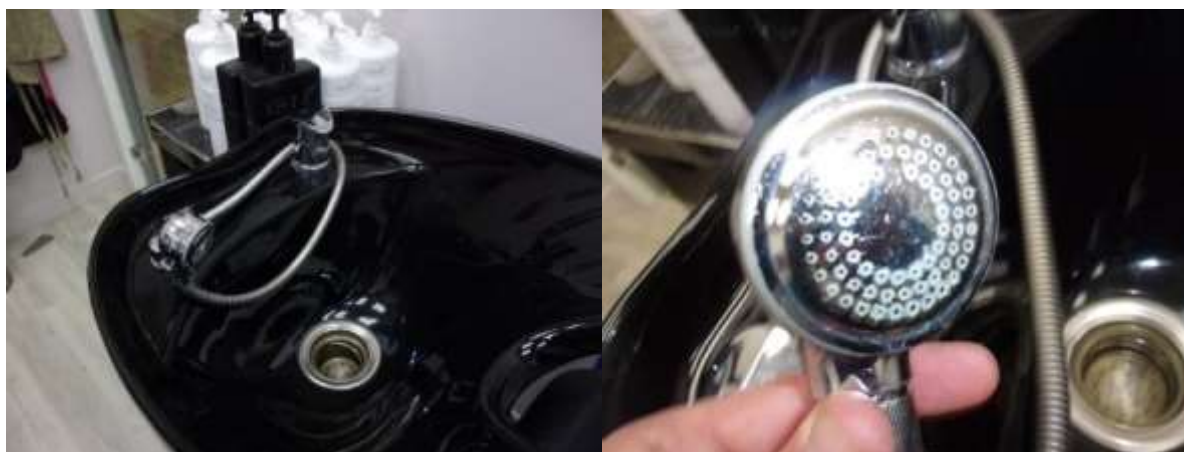
SPRAY OUTLET

Technical Data	
Outlet Type	Sink / Spray Hose
Location	LGF Hair Salon
Outlet Fed from	CWST 1 and CAL 2
Risk Assessment Data	
Outlet condition	Good
Estimated frequency of use	Little Used
Nature of exposed population	AVERAGE / INCREASED SUSCEPTIBITLY , SEE PAGE 2
Degree of exposure	Low (<1 hrs/wk)
Direct Spray Formation	Yes
Dirt / Scale Present	Light
Biological Slime Present	None
Extent of Corrosion	None
Temperature °C	CWS 19.6°C HWS 65.8°C

RISK RATING HIGH

ACTION ID/ ASSET	LOCATION	HAZARD DESCRIPTION	ACTUAL RISK RATING	RECOMMENDED ACTION	ACTION REQUIRED	COMPANY / DATE COMPLETED	RESIDUAL RISK FOLLOWING COMPLETION OF ACTION	SIGNED
34-Scale – Spray Outlet	LGF Hair Salon	Light scale deposits present to outlet.	MEDIUM	Clean and descale outlet. Ensure a regular cleaning programme is in place to minimise the risk of microbial proliferation.	3 MONTHS		LOW	
35-Scald Risk	See Domestic Water Temperature Survey	Stored water temperature too high presenting scald risk (greater than 65°C).	MEDIUM	Reduce water heater storage temperature to achieve 50-60°C at all outlets.	3 MONTHS		LOW	
36-TMV Outlet	See Domestic Water Temperature Survey	The temperature at the TMV outlet is outside the range 39°C to 43°C.	LOW	Adjust TMV so temperature is in the range 39°C to 43°C.	6 MONTHS		LOW	
37-Flexi Hoses	See asset table for locations	It could not be determined if the flexi hoses on site are WRAS approved.	LOW	We advise that all non-WRAS approved flexible hoses be replaced with fixed copper connections. If flexible hoses are required due to space restrictions, then WRAS compliant hoses should be fitted.	6 MONTHS		LOW

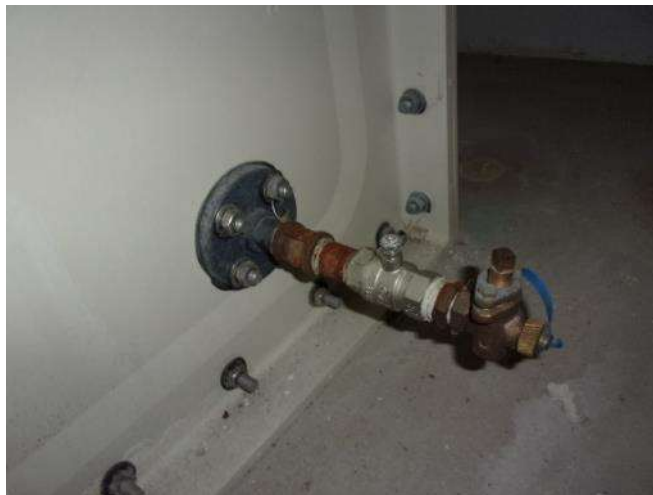
Deadlegs

Technical Data	
System Type	Deadleg 1
Location	Basement Plant Room
System Serves	CWST 1 Drain Valve
System Fed from	CWST 1
Risk Assessment Data	
Size	22mm x 10cm
Risk Rating High/Medium	Medium

RISK RATING MEDIUM

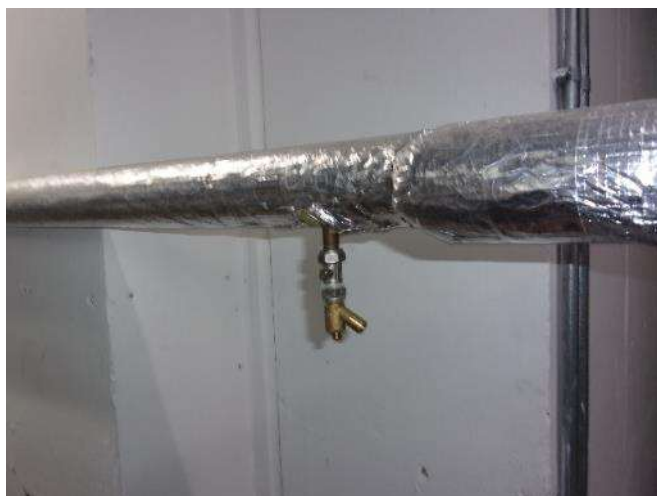
Deadlegs

Technical Data	
System Type	Deadleg 2
Location	Basement Plant Room
System Serves	Drain Valve
System Fed from	CWST 1
Risk Assessment Data	
Size	15mm x 40mm
Risk Rating High/Medium	Medium

RISK RATING MEDIUM

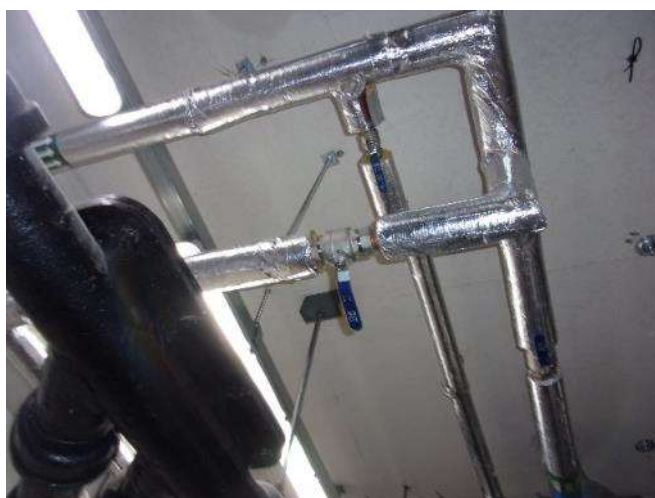
Deadlegs

Technical Data	
System Type	Deadleg 3
Location	Basement Plant Room
System Serves	Mains Bypass
System Fed from	CWST 1 / MAINS
Risk Assessment Data	
Size	42mm x 1m / 42mm x 40cm
Risk Rating High/Medium	Medium

RISK RATING MEDIUM

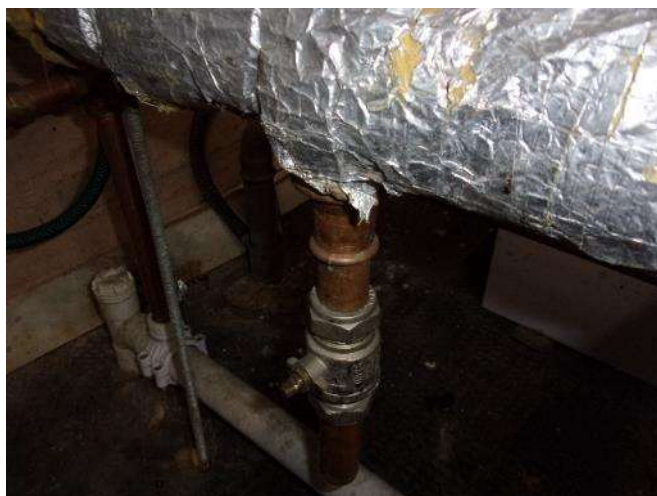
Deadlegs

Technical Data	
System Type	Deadleg 5
Location	External Bin Store
System Serves	Drain Valve
System Fed from	CWST 1
Risk Assessment Data	
Size	28mm x 10cm
Risk Rating High/Medium	Medium

RISK RATING MEDIUM

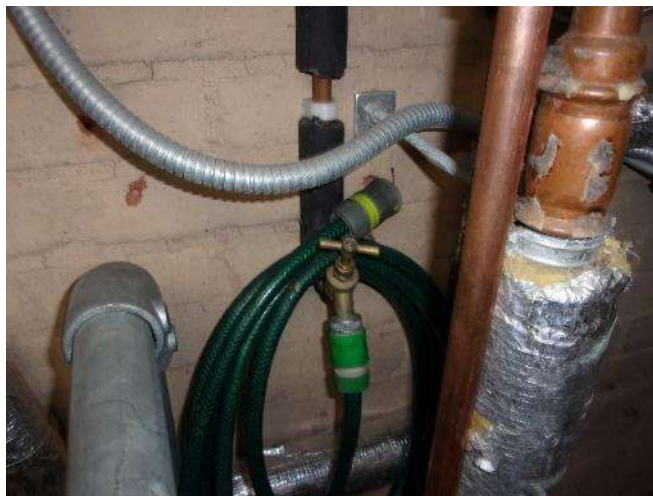
Technical Data	
System Type	Bib Tap
System Reference	BT
Location	See asset table for locations
System Fed from	CWST 1
Risk Assessment Data	
System condition	Good
Estimated frequency of use	Unknown
Direct Spray Formation	Unknown

RISK RATING MEDIUM

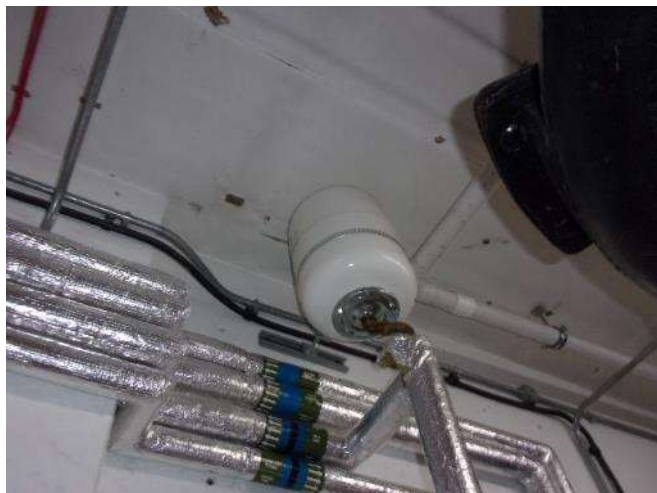
Typical Expansion Vessel

Location	See asset table for locations
Service/Equipment supplied	Calorifiers / Pumps Sets

RISK RATING MEDIUM

ACTION ID/ ASSET	LOCATION	HAZARD DESCRIPTION	ACTUAL RISK RATING	RECOMMENDED ACTION	ACTION REQUIRED	COMPANY / DATE COMPLETED	RESIDUAL RISK FOLLOWING COMPLETION OF ACTION	SIGNED
27-Expansion Vessel	See asset table for locations- Electric Water Heaters	Expansion vessel installed horizontally / upside down.	MEDIUM	Reconfigure pipework to install vertically.	3 MONTHS		LOW	
28-Pump Set	Basement Plant Room	Pump set present.	MEDIUM	Ensure any standby pumps are used at least weekly to prevent stagnation, as per HSG 274, part 2. If not used, standby units must be flushed weekly.	3 MONTHS		LOW	
29-TMVS	See asset table for locations	It should be ensured that all TMVs have annual servicing and failsafe checks completed.	MEDIUM	There are no records present for annual failsafe checks and servicing. Consider removal of TMVs where not required.	3 MONTHS		LOW	
30-TMTS	See asset table for locations	It should be ensured that all TMTs have annual servicing and failsafe checks completed.	MEDIUM	There are no records present for annual failsafe checks and servicing.	3 MONTHS		LOW

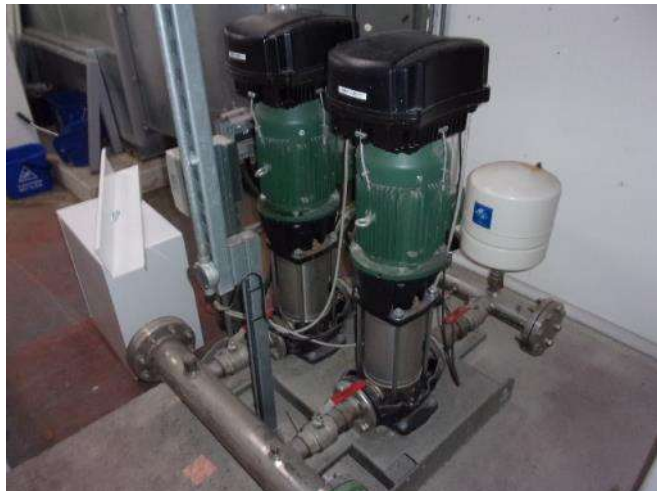
Typical Pump/Booster Set

Location	Basement Plant Room
Service/Equipment supplied	CWST 1

RISK RATING MEDIUM

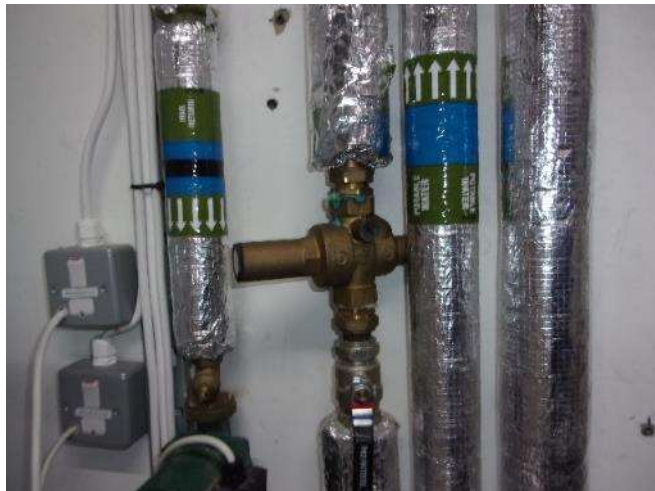
System Type	Typical Pressure Reducing Valve (Presumed with Filter)
Location	See asset table for locations

RISK RATING MEDIUM

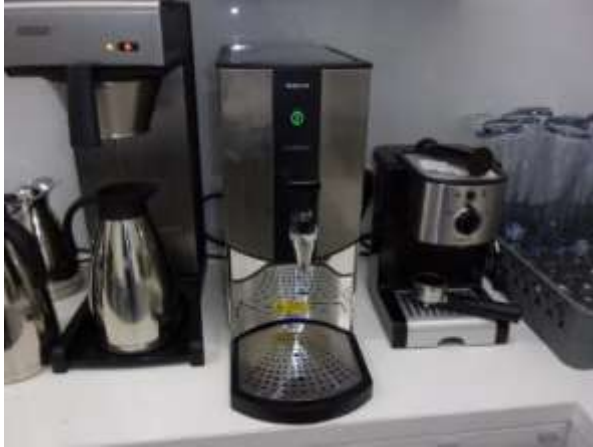
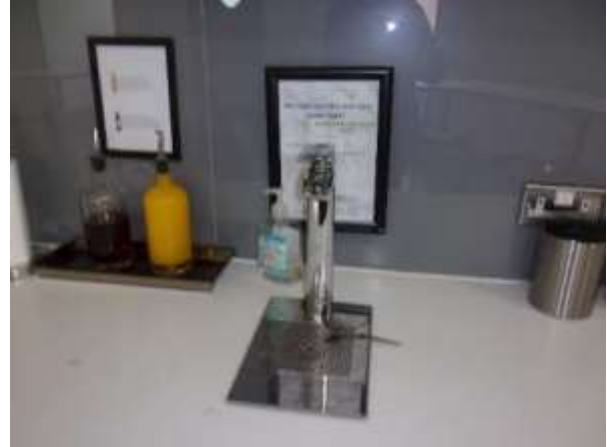
Typical drinking water dispensers, hot and cold vend

System Type	Drinking water dispensers, hot and cold vend
Location	See asset table for locations

RISK RATING LOW
