# Asbestos Survey Report

Temple Court  
13a Cathedral Road  
Cardiff

31st October 2014

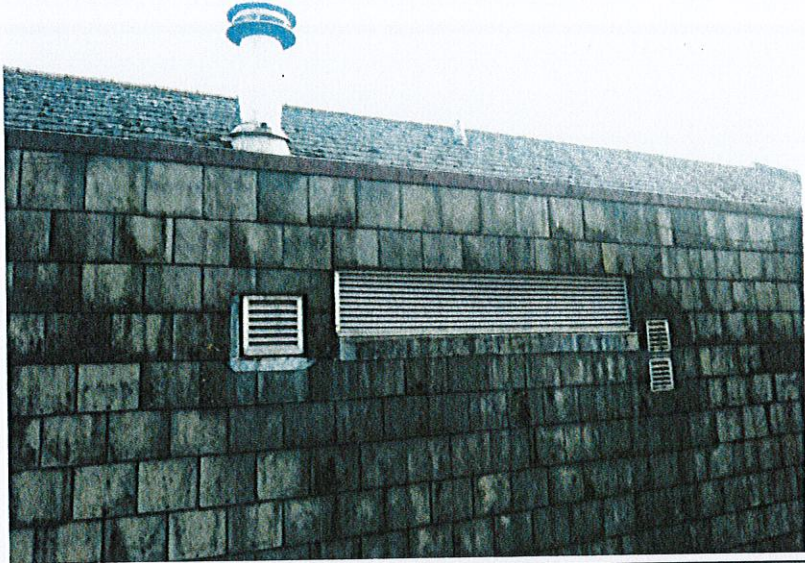
Client	The Office UK				
Survey Address	13a Cathedral Road, Cardiff, CF11 9HA				
Building	Temple Court				
Location	External, Roofing and fascia tiles				
Survey Ref	8177/141031				
Sample Ref	No Sample Taken				
<b>Photo Details</b>

<b>Risk Matrix</b>					
Asbestos Type	Chrysotile (Identified)	1	Product/Use	Asbestos-Reinforced Composites	1
Condition	Good Condition	0	Treatment	Composite Materials	0
Identified Risk	Very Low	2	Action	Action D	
Extent	As Seen				
Accessibility	Easy Access				
Remarks	<b>No sign of deterioration since last survey dated 24/06/2008.</b>
